**Underwater Videographic and Hydroacoustic Eelgrass Survey
Chimacum/Irondale Beach Restoration Site
September 12, 2006**

James G. Norris and Ian E. Fraser

North Olympic Salmon Coalition
PO Box 699
Port Townsend, WA 98368

November 9, 2006

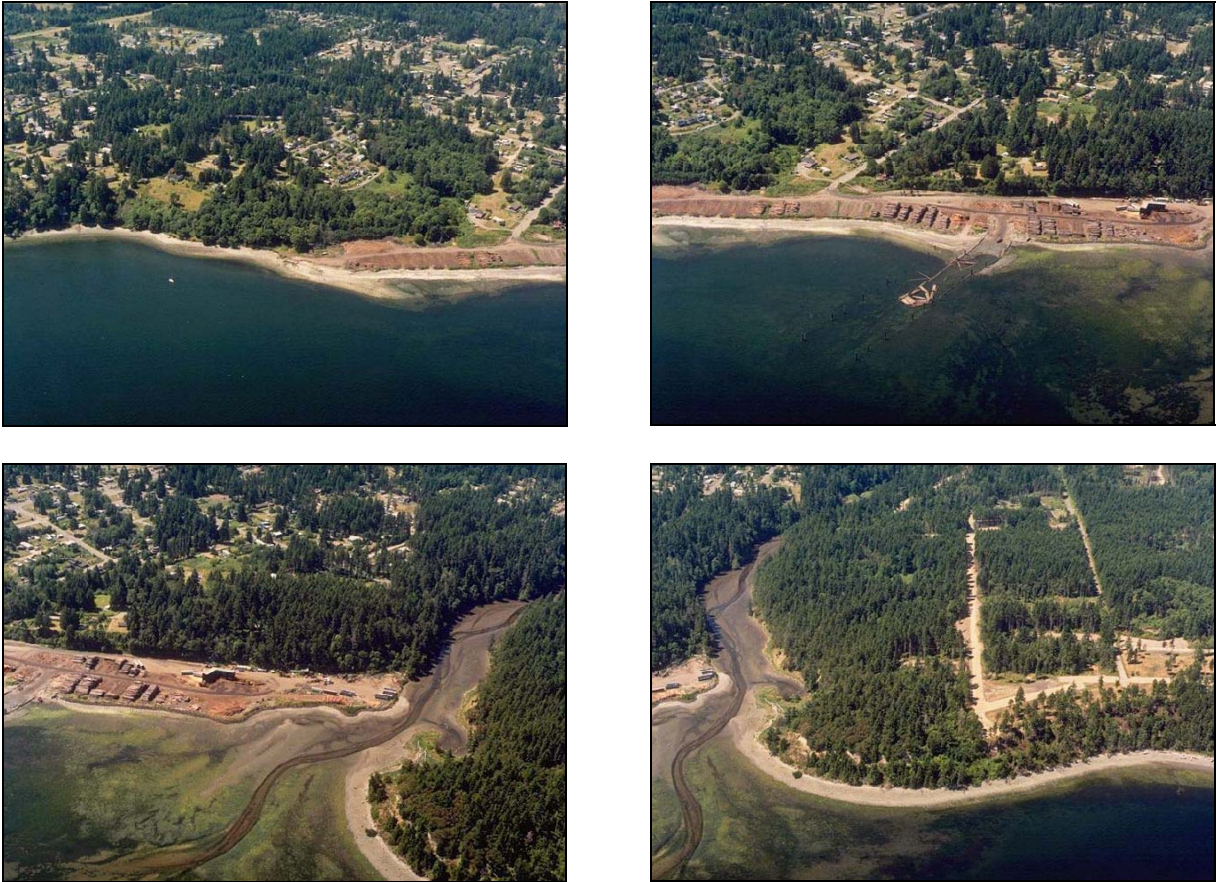
Figure 2. Aerial photographs of the study area taken on July 12, 1994 at 12:19 pm (tide stage: -0.4 ft). (Source: Washington State Department of Ecology web site at <http://apps.ecy.wa.gov/shorephotos>.)

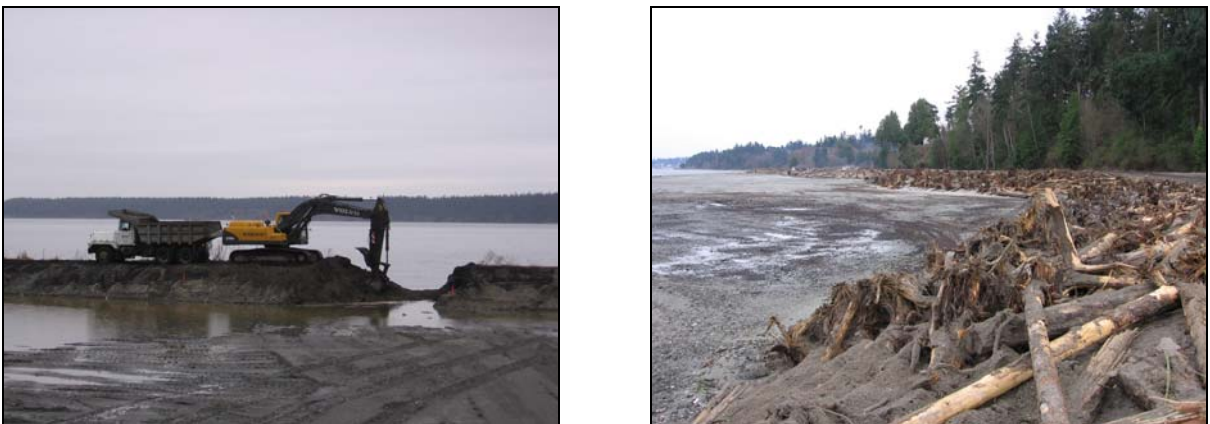
Figure 3. Photographs during and after work at the Chimacum/Irondale beach restoration site.

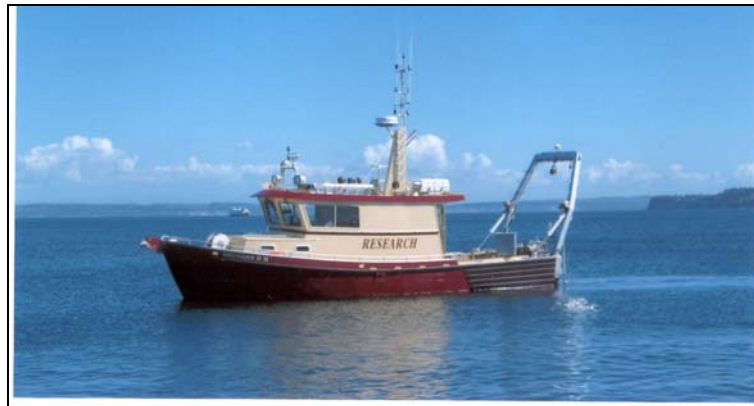
We conducted sampling aboard the 36-ft *R/V Brendan D II* (Fig. 5). We acquired position data using a sub-meter differential global positioning system (DGPS) with the antenna located at the tip of the A-frame used to deploy the camera towfish. Differential corrections were received from the United States Coast Guard public DGPS network using the NAD 83 datum. A laptop computer running Hypack Max hydrographic survey software stored position data, depth data from one echosounder (Garmin), and user-supplied transect information onto its hard drive. Position data were stored in both latitude/longitude and State Plane coordinates (Washington North, US Survey meters). All data were updated at 1 s intervals. Table 2 lists the equipment used during this survey.

Figure 5. The *R/V Brendan D II*.

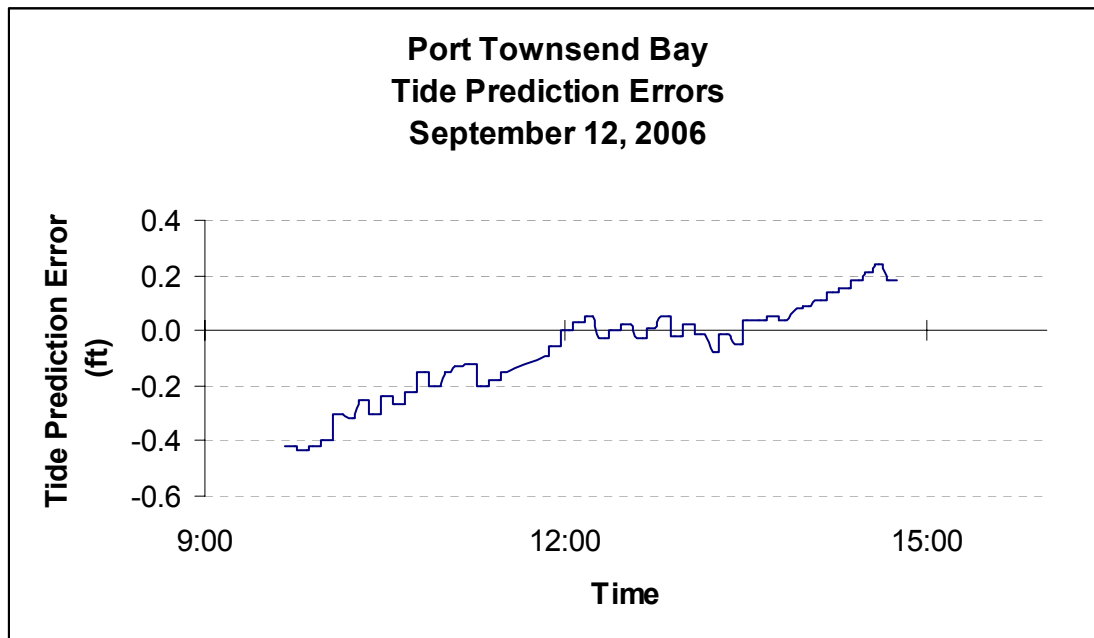
Corrected depth equals depth below the transducer plus the transducer offset minus the predicted tidal height plus the tide prediction error. The transducer offsets were measured just prior to the survey (1.36 ft Garmin; 1.17 ft Biosonics). We used the computer program Tides and Currents Pro 3.0 (Nobletec Corporation) to get predicted tide heights (at 6 min intervals) for the tide prediction station closest to the survey site, in this case Port Townsend (station ID 0995; 48 06.90 N 122 45.00 W). We computed tide prediction errors at the reference station by comparing the computer program predicted tide heights with actual observed tide heights published by the National Oceanic and Atmospheric Administration on their web site (<http://tidesandcurrents.noaa.gov/>). The tide prediction errors during the time of the survey ranged from -0.4 ft to +0.2 ft (Fig. 6).

Figure 6. Tide prediction errors for Port Townsend Bay on September 12, 2006.

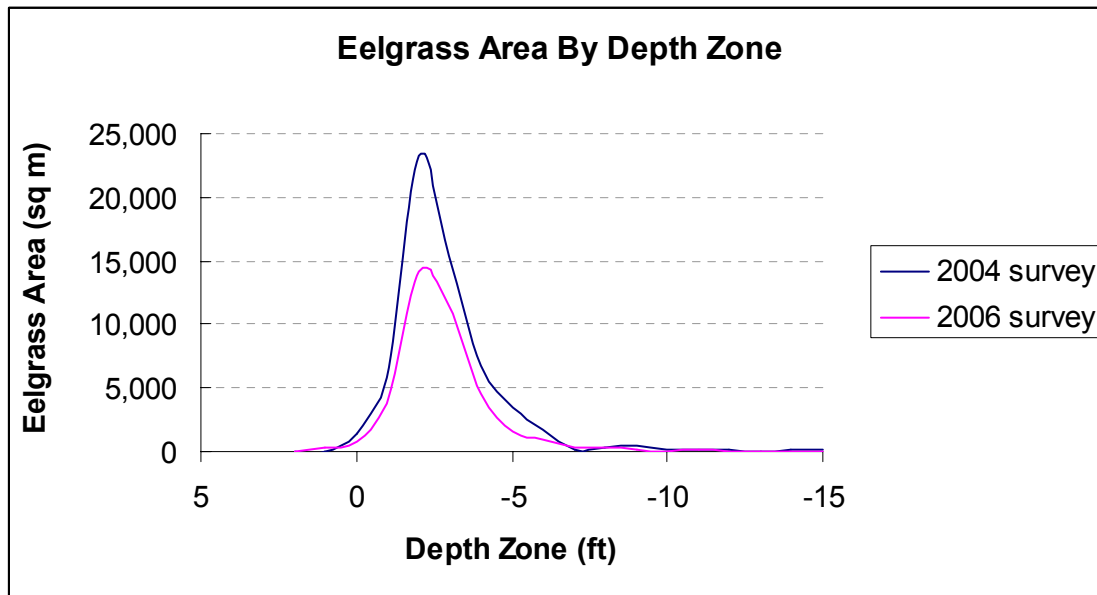
Figure 12. Estimated eelgrass areas by depth zone from the 2004 and 2006 surveys.
