# **SALMON CREEK ESTUARY RESTORATION AND WOOD WASTE REMOVAL: LESSONS LEARNED REPORT**

**FY 2008-2011**

**North Olympic Salmon Coalition**

**for the Salmon Recovery Funding Board**

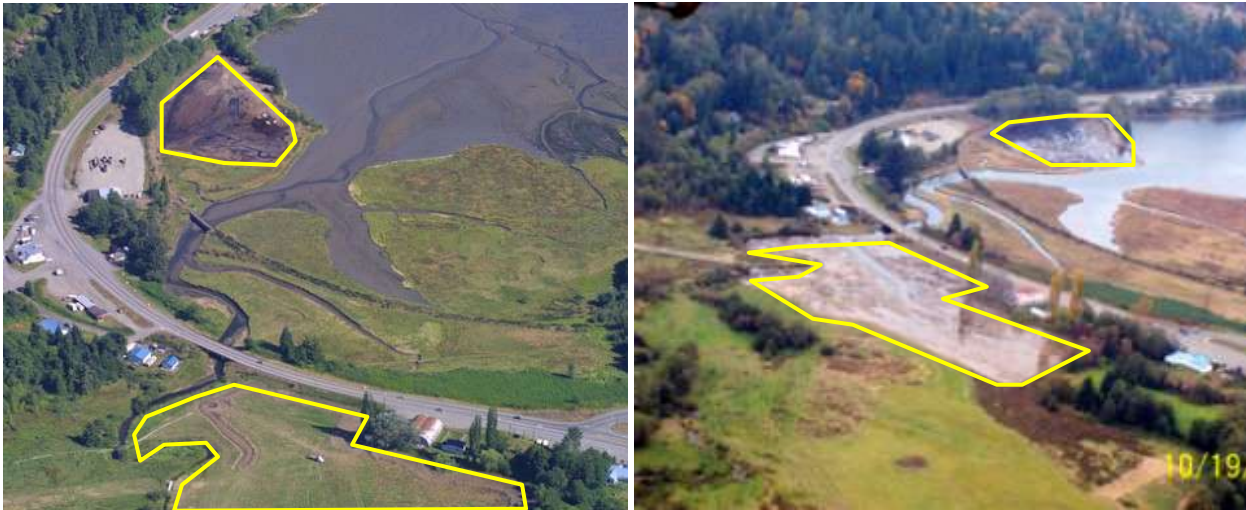
**Figure 2.2:** Salmon Creek estuary project aerial view during restoration (left) and after restoration (right).

The project included two sites, which are referred to as the ‘North’ and ‘South’ sites, **Figure 1.2**. The North site included an old log peeling and veneer mill. Wood waste was placed atop the historic estuary at the head of Discovery Bay mid-century during a brief history of log peeling and veneer making at the site. Ground water seeping through the wood waste ‘leached’ natural chemicals from the wood. These leachates were toxic, containing high levels of sulfur, ammonia and other chemicals. Leachates created toxic conditions for aquatic wildlife in an existing tidal channel adjacent to the wood waste pile. In order to grade the site to marsh surface elevation and improve water quality, the project required the removal of 4,700 cubic yards of sawdust and 25,000 cubic yards of other types of wood waste and gravel. Historic tidal channels filled with wood chips, were revealed and excavated when the wood waste was removed.

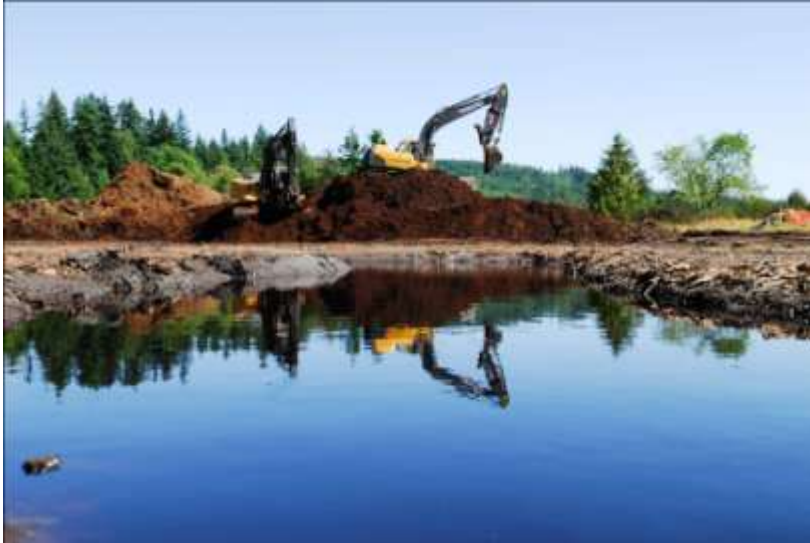
**Figure 2.3:** Excavation of the North Site Estuary, 2008 (Photo courtesy of NOAA)

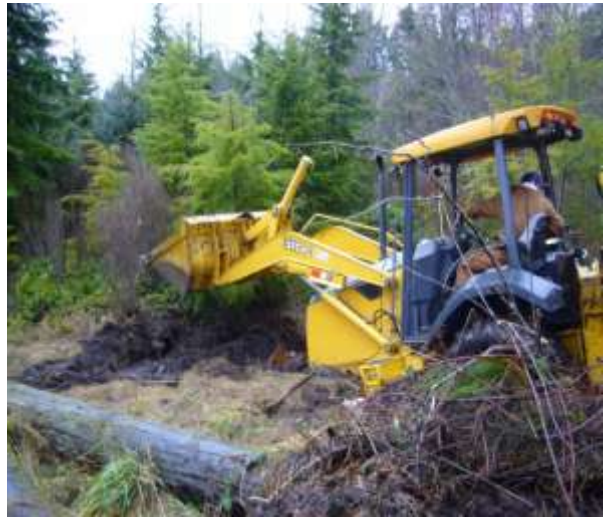
**Figure3.1:** Areas thought to be upland, turned out to be pockets of wood waste saturated with ground water and unsuitable for our exploration equipment access.

It was known that a sawdust pile existed at the North Site covering approximately 20% of the 4 acres. What wasn't known until the backhoe accessed other areas of the site, seeming to be upland, was that close to 95% of the North Site contained wood waste. Areas covered with upland vegetation and seeming to be stable turned out to be nothing more than wood waste under highly saturated conditions, with upland vegetation growing on top. Unfortunately it was the weight of the backhoe that revealed the hidden wood waste swamp at the 'upland' portion of the North Site. What's a restoration project without at least one sunken backhoe incident?

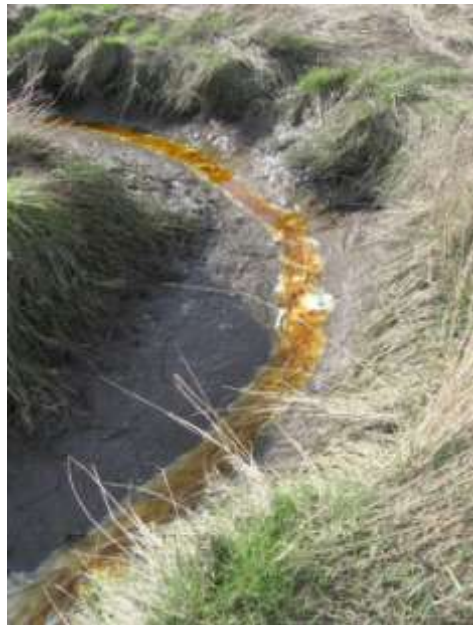
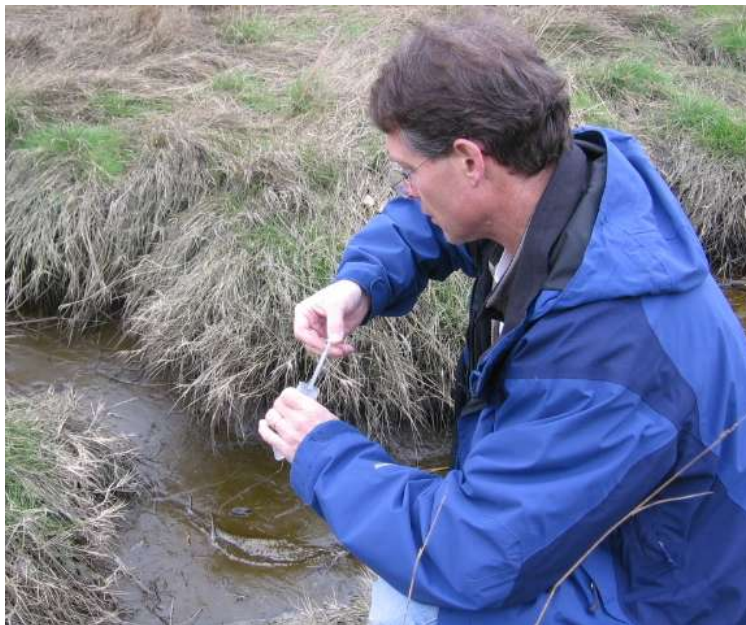
**Figure 4.1:** Left: White sulfur-loving bacteria in a tidal channel adjacent to the wood waste pile; Right: Joel Elliot, a professor at University of Puget Sound, collects samples of the bacteria for testing.

During our research on wood waste and leachates, there was a newspaper article on the Commencement Bay Restoration Project and the presence of sulfur loving bacteria. Joel Elliott, featured in the newspaper article, is a professor at University of Puget Sound. He had recently published a paper on sulfur-loving *Beggiatoa* bacteria growing on wood waste piles in the marine environment. After sending him photos of the white mats of bacteria in the tidal channel adjacent to the pile at our North Site, he immediately came to the site and took sample of bacteria and ran sulfide samples on the water in the channel (**Figure 4.1**). He observed white sulfur loving bacteria from the sawdust pile where it appeared as thick mats of white filaments in deep-red tannin stained water. These mats extended to the tidal channel mouth where it appeared as a thin film on the rocks. He also noted distinct absence of tunicate holes and castings in the channel which was a variation from the healthy populations of tunicates in channels not exposed to the leachate. Dr. Elliott confirmed the suspicion that indeed the site had a leachate problem, and it was substantial.

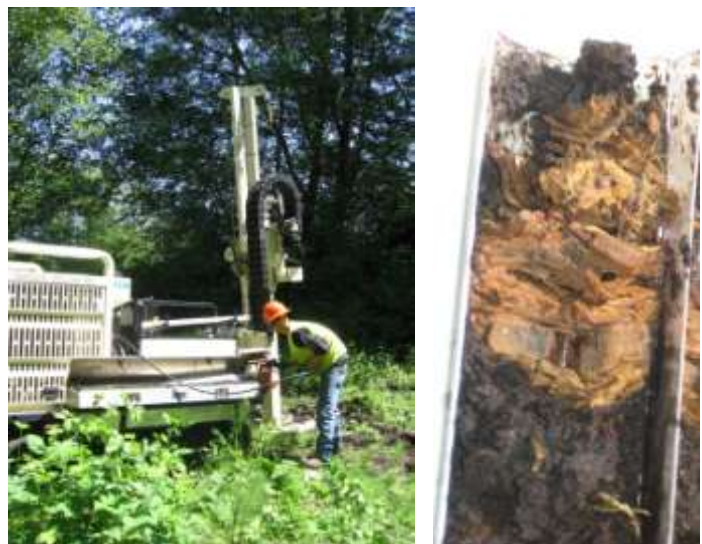
**Figure 6.1:** Left: Geoprobe used to take core samples of site; Right: Resulting core sample from project site with wood waste on top.

A low cost approach to the second soils investigation was attempted first. The project manager, habitat engineer and NOSC intern sampled twenty one hand augur holes in and adjacent to the project footprint. In places the wood waste was too deep to effectively sample with the augurs, and in other places the origin of the organics being encountered was uncertain. It became clear that a second, professional investigation was needed. The soils were saturated and given the previous incident with the backhoe sinking in wood waste, we needed a machine that could navigate the terrain safely in order to succeed. Areas that seemed to be

upland (as indicated by vegetation composition) may be disguising extensive deposits of wood waste and we had two acres of vegetated, swampy, uplands to explore. It was determined that a machine called a 'Geoprobe' was the tool for the job; not only could it pull clean samples, it could access the soggy soils of the site. In addition there was a substantial area developed for the veneer operations where a lens of gravel was concealing more wood waste below. Thus, it was important that a thorough job of determining the *vertical* and *horizontal* extent of wood waste across the site would need to be completed. This information was used to inform the re-design of the project footprint, determine finish elevations and establish directives for the extent of excavation and need for over excavation and backfilling.

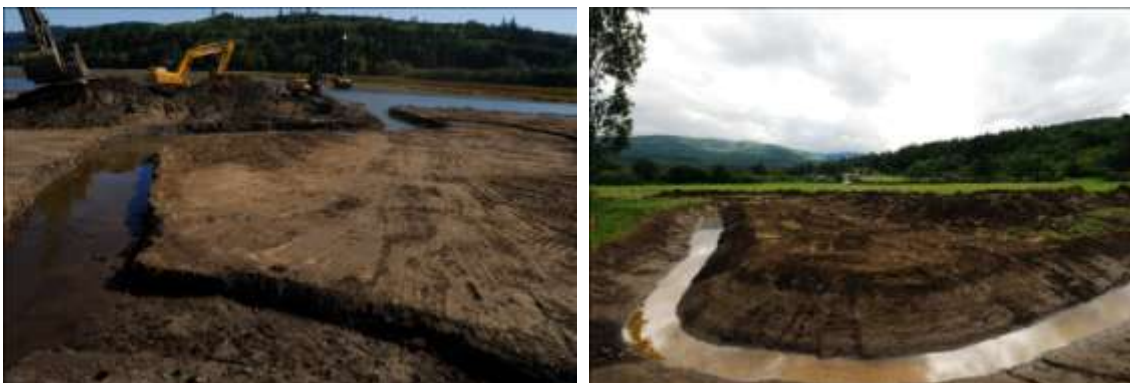
**Figure 9.1:** Tidal channel construction at Salmon Creek Estuary.

Digging channels proved not to be a construction issue, the contractor employed effective water management techniques on the site and excavator operators succeeded at digging the fine details of sinuosity and depth depicted on the plans.

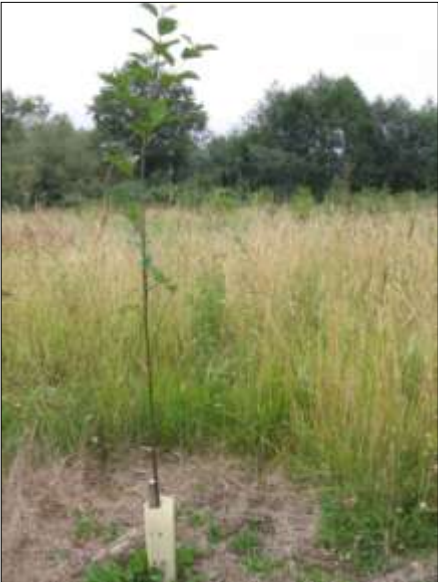
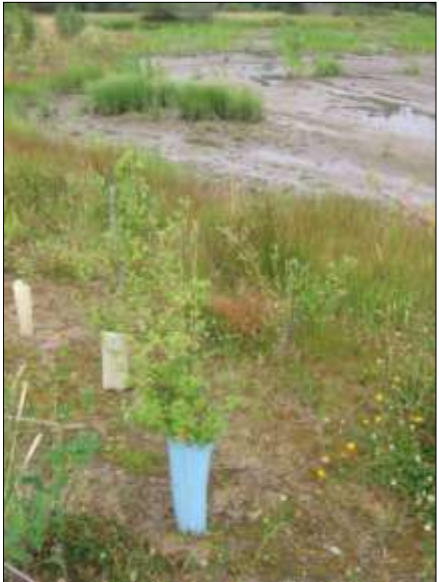
**Figure 10.1:** Plant growth in one season
