MORSE CREEK REMEANDER RESTORATION: MONITORING REPORT YEAR THREE

North Olympic Salmon Coalition and Mike Haggerty
Consulting

October 2012

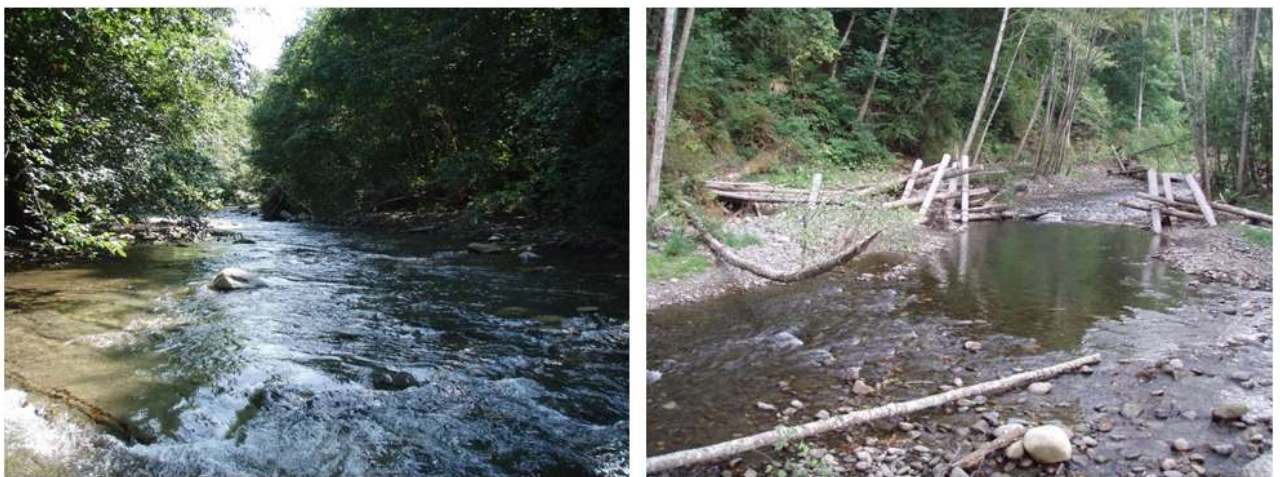
Figure 1.2. Morse Restoration Project before (old channel on left) and after (new channel on right).

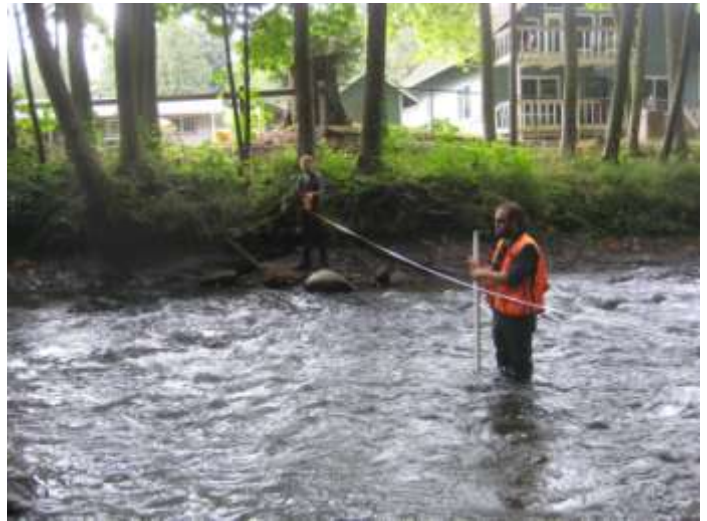
Figure 3.1. Channel thalweg depth and wetted width measurements.

For primary transects the following parameters were measured: thalweg depth (to nearest 0.01 meter), wetted width (to nearest 0.1 meter), bankfull width (to nearest 0.1 meter), bar width (to nearest 0.1 meter), thalweg soft sediment (Yes or No, sediment less than 16 mm), habitat unit ID (from habitat survey), particle size and depth at left edge of water, 25, 50, 75, and 100 percent wetted width, GPS location, and a minimum of two photos (one looking downstream and one

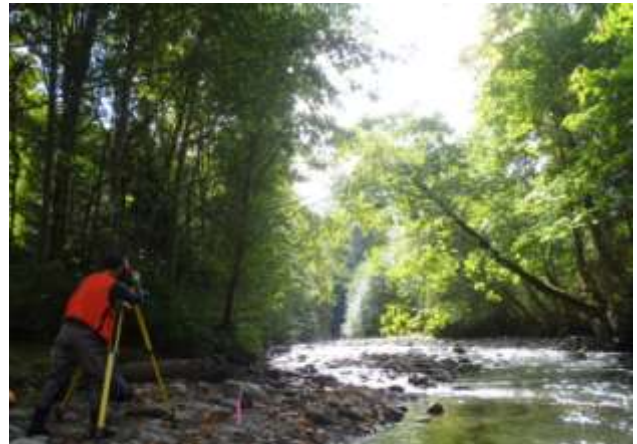
A channel profile was run upstream from the start of each surveyed reach. Water surface and substrate elevations were measured and recorded at all primary and secondary transects. Additional profile measurements between transects were also made, in some cases at intervals as small as five meters. Standard survey methods were employed using an auto level, tripod, and stadia rod (Figure 3.3). Reference elevations were established at a minimum of two points at each of the permanent cross-sections. All reference elevations were surveyed within a common datum.

Figure 3.3. Channel profile survey on Morse Creek.

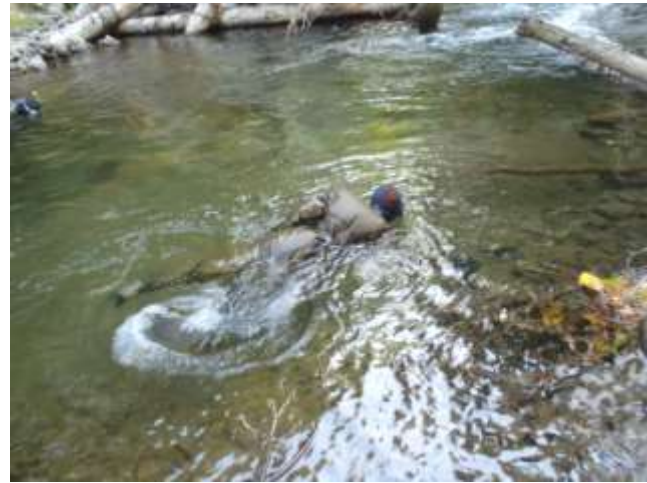
Figure 3.5. Snorkel surveys on Morse Creek.

Juvenile salmonids were recorded based on species and age class. Age class was based on size. Age 0+ coho were less than 70 mm length and age 1+ coho were 70-140 mm length. Age 0+ trout were less than 60 mm, age 1+ trout were 60-100 mm, and age 2+ trout were greater than 100 mm. No other juvenile salmonid species were observed within stream segments surveyed. Adult salmonid species were observed and recorded.

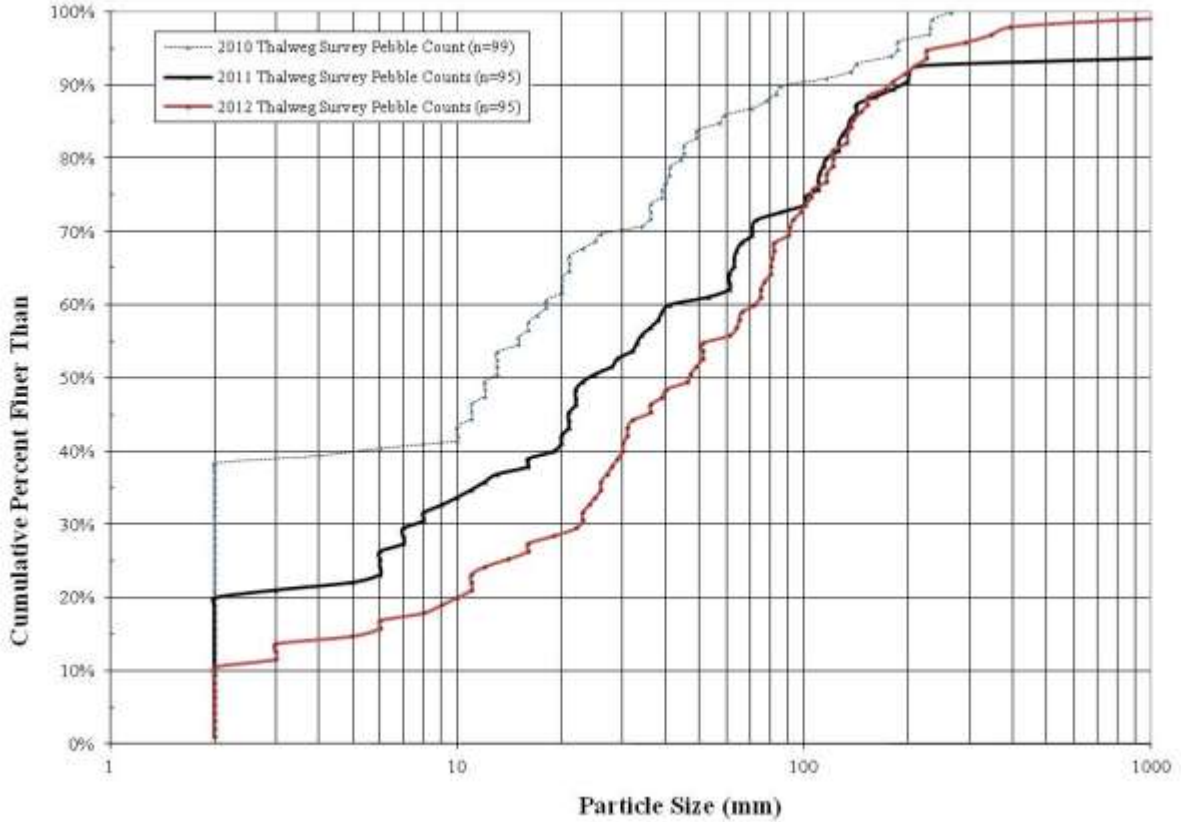
(19%). In 2012, only 11 percent of the particles were classified as fines; decrease of 71 percent from 2010. Median particle size increased from 13mm in 2010 to 24mm in 2011, to 47 mm in 2012 (261% increase).

Figure 4.2. New channel reach particle size distribution in 2010, 2011, and 2012.

In 2011, the new channel still had a high proportion of fine sediment. Conditions appeared improved in 2012. Fines made up 38, 20, and 11 percent of the thalweg pebbles counted in 2010, 2011, and 2012. Several Chinook salmon redds were observed within the new channel reach during surveys in 2012.

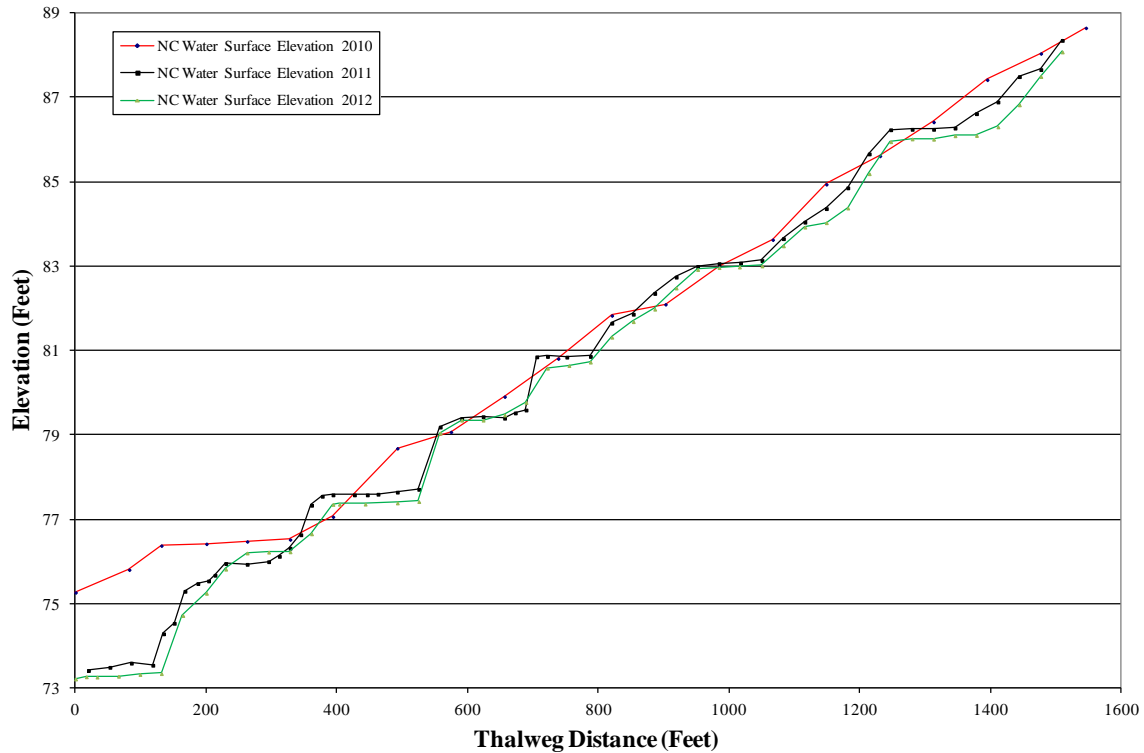
Reach level stream gradient was 0.87, 1.00, and 0.98 percent in 2010, 2011, and 2012 respectively. The measured change in gradient between 2010 and 2011/12 is most directly attributable to the observed head-cutting at the downstream end of the new channel (see Figure 4.4).

Figure 4.4. New channel reach water surface profile for 2010, 2011, and 2012.

The channel has evolved from a uniformly plane bed channel into a pool-riffle channel type. Figure 4.4 and Figure 5.1 clearly illustrate a sequence of lower and higher gradient habitat units. Figure 5.1 also shows that significant thalweg deepening occurred between survey years. Most of the lowered thalweg elevations (deeper spots) measured in 2011 and 2012 correspond to scour pools (thalweg elevation lowering in the lower 100 meters was caused by head cutting). At one location there was at least eight vertical feet of thalweg scour. These pools were formed when water scoured around the constructed logjams.

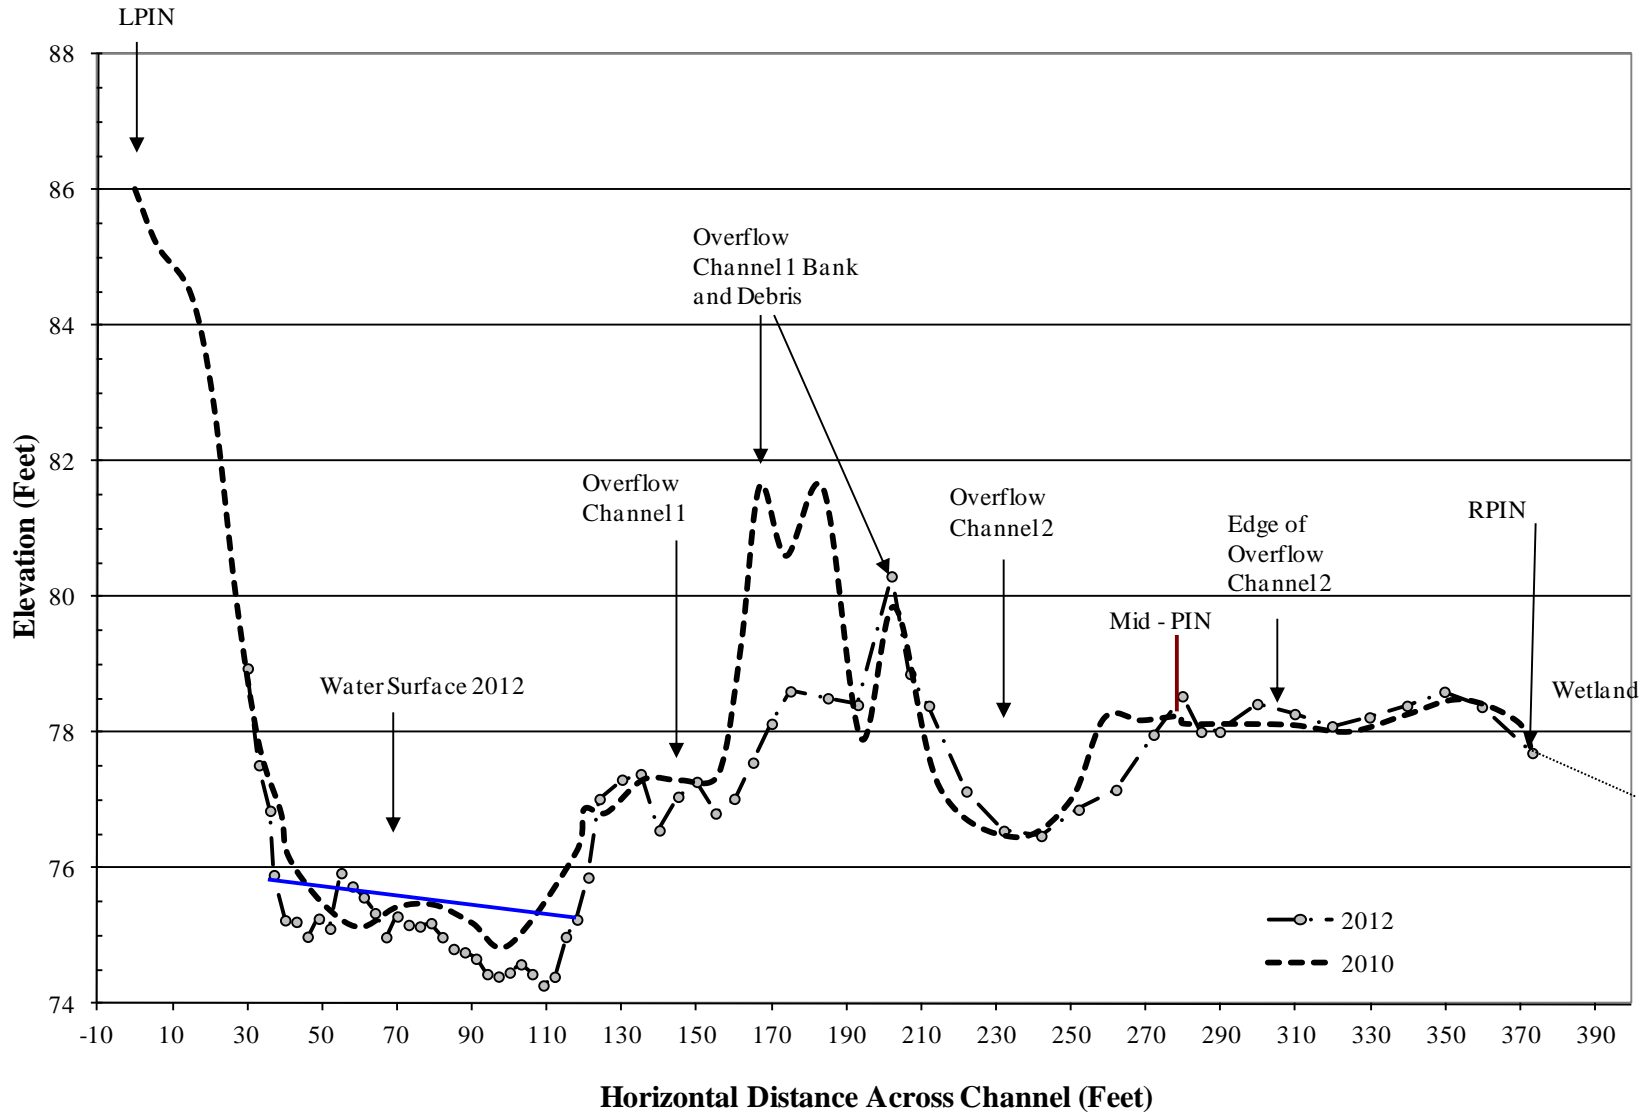
Figure 4.5. Morse Creek New Channel Cross-Section 1 in 2010 and 2012.

Results from the cross-section surveys are presented above in Sections 4.1.3, 4.2.3, 4.3.3, and 4.4.1. Within the new channel reach significant change was observed at all five cross-sections. At NC-XSEC-1 (see Figure 4.5 and Figure 4.6) the thalweg elevation incised ~0.6 ft. Within the primary channel average bed elevation decreased 0.4 ft. Bankfull area (not including the overflow channel) increased from 405 sq ft² to 464 ft² in 2012. The downward shift in bed elevation at this cross-section is a result of head cutting. Particle size distribution at NC-XSEC-1 increased from a median particle size of less than 2 mm to 72mm in 2011, and then decreased to 47 mm in 2012.

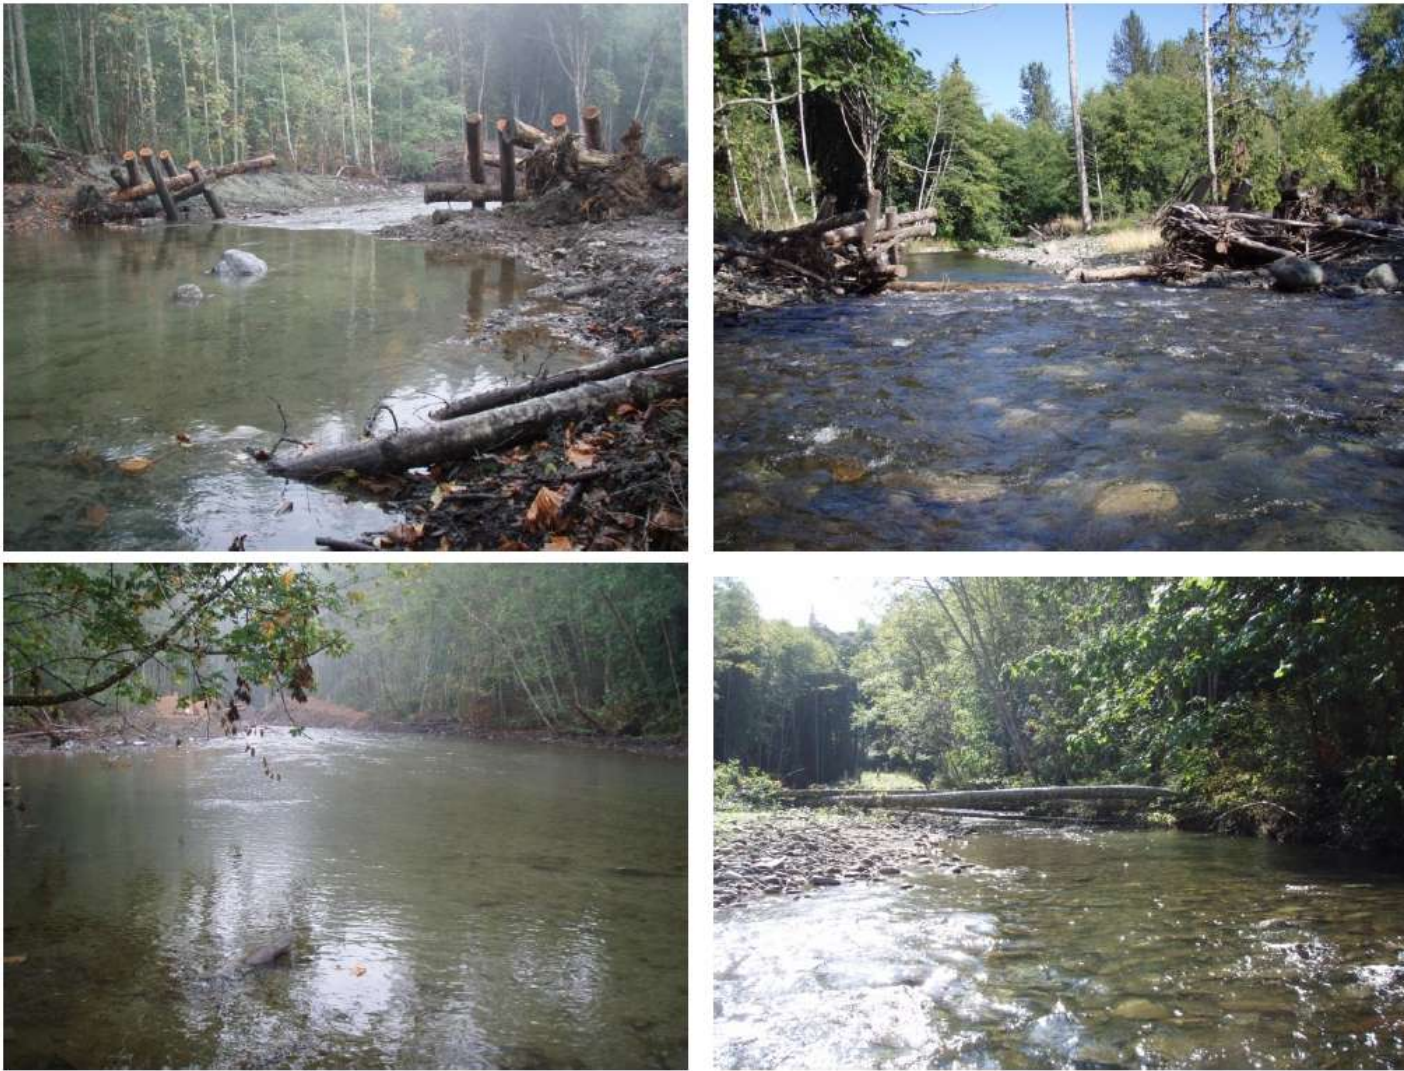
Figure 4.6. Photos from Cross-Section NC-1 looking downstream (above) and upstream (below) in 2010 (left) and 2011 (right). No photos available for 2012.

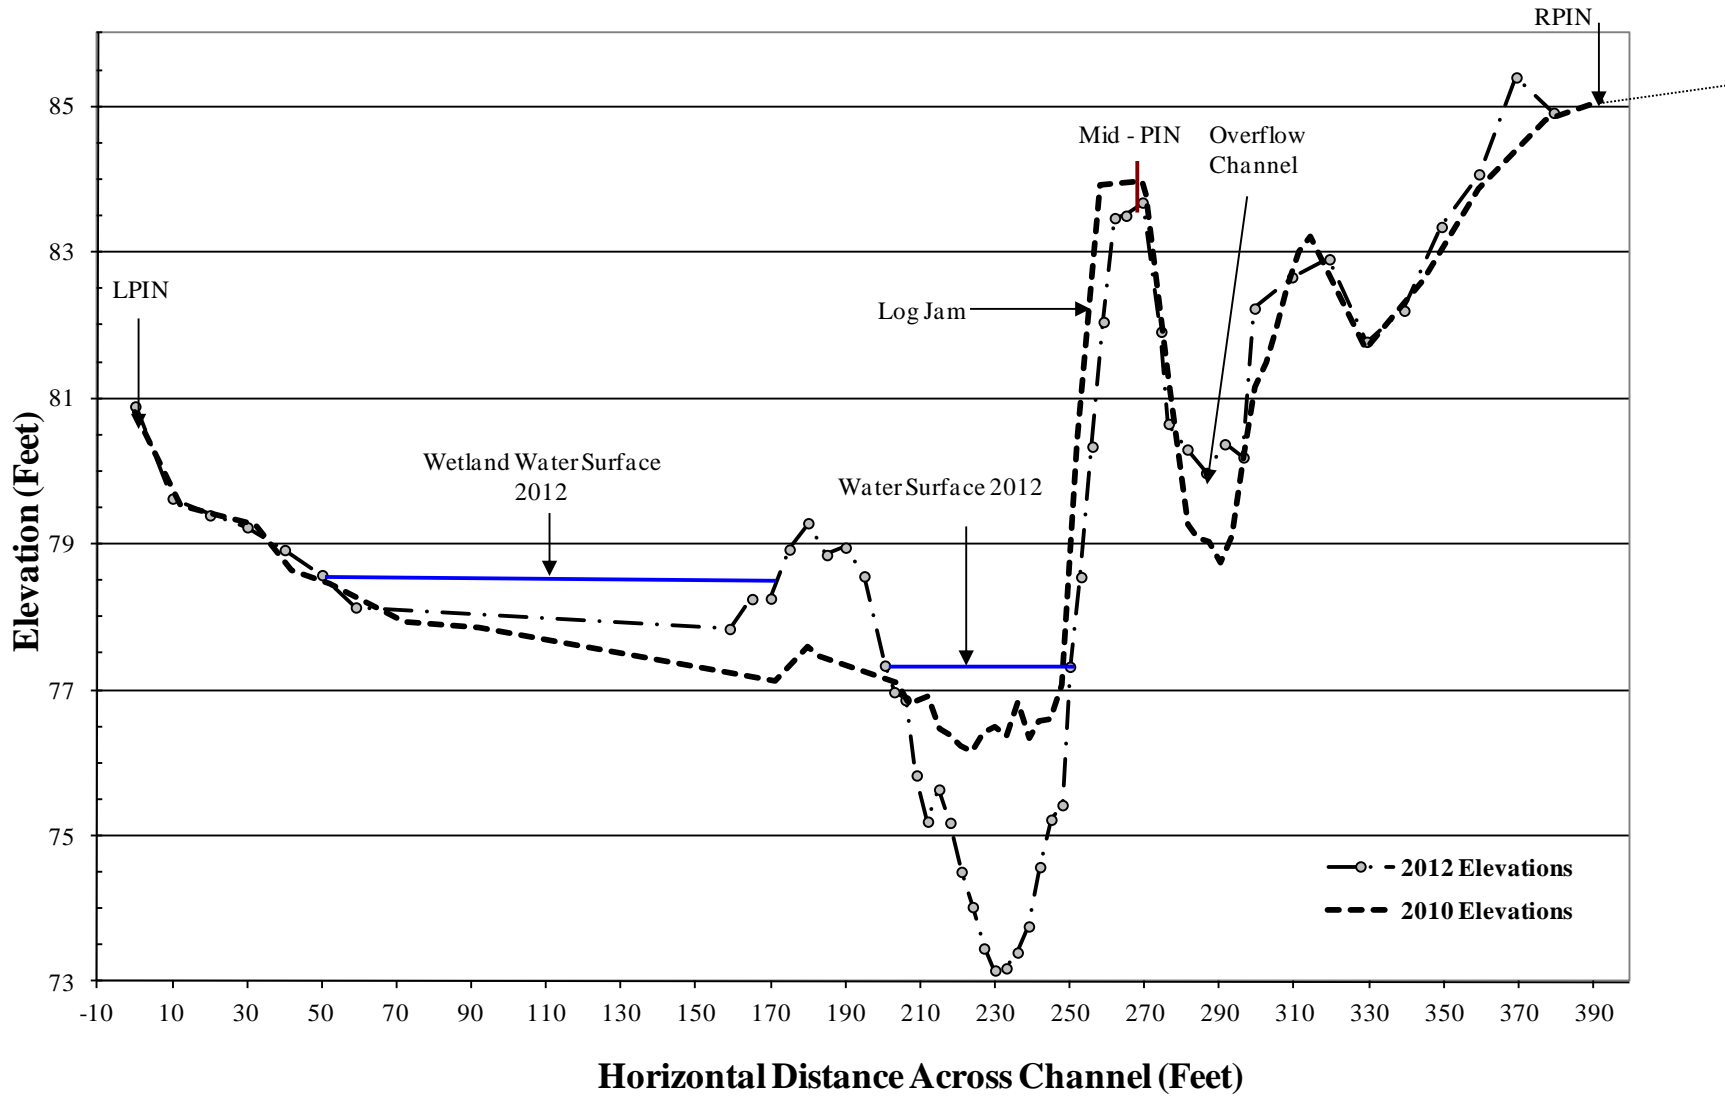
Figure 4.7. Morse Creek New Channel Cross-Section 2 in 2010 and 2012.

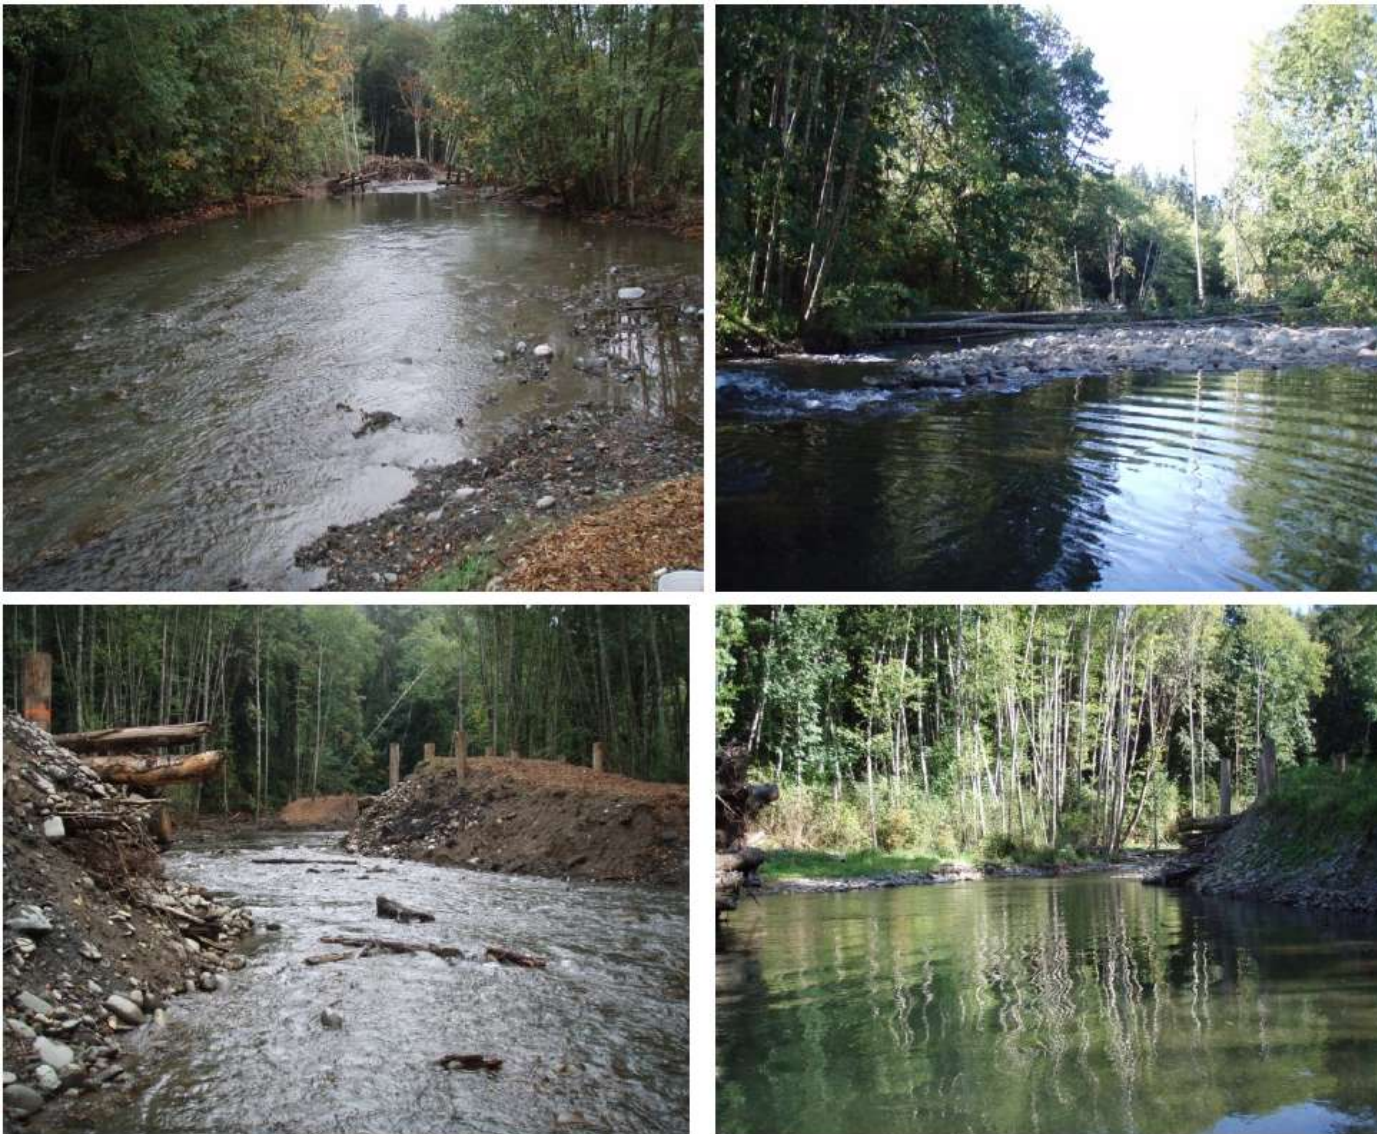
Figure 4.8. Photos from Cross-Section NC-2 looking downstream (above) and upstream (below) in 2010 (left) and 2011 (right). No photos available for 2012.

At NC-XSEC 2 (see Figure 4.7 and Figure 4.8) the thalweg elevation incised 1.3 ft. Within the primary channel average bed elevation decreased 0.4 ft. Bankfull area (not including the right bank side channel) increased from 154 ft² to 180 ft² in

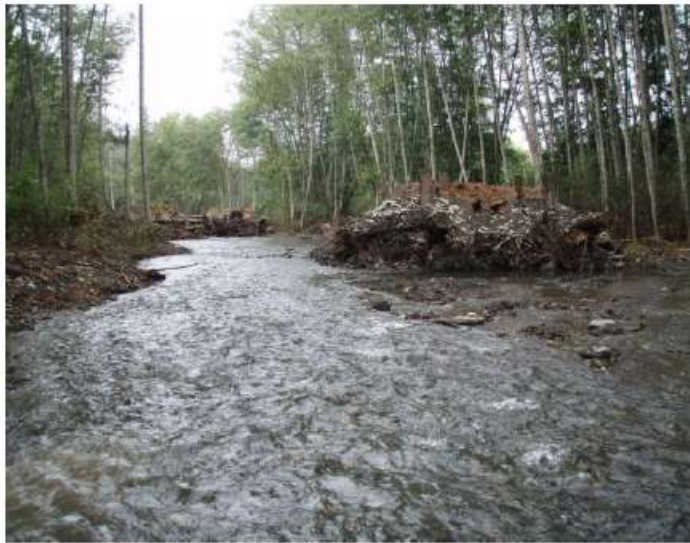
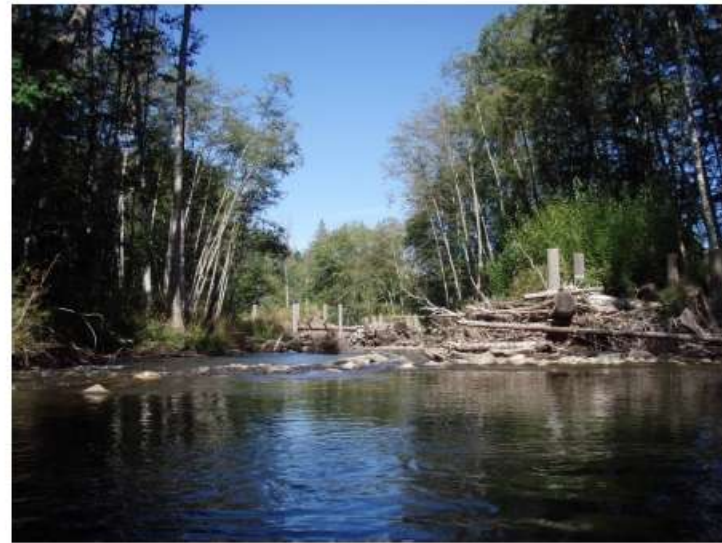
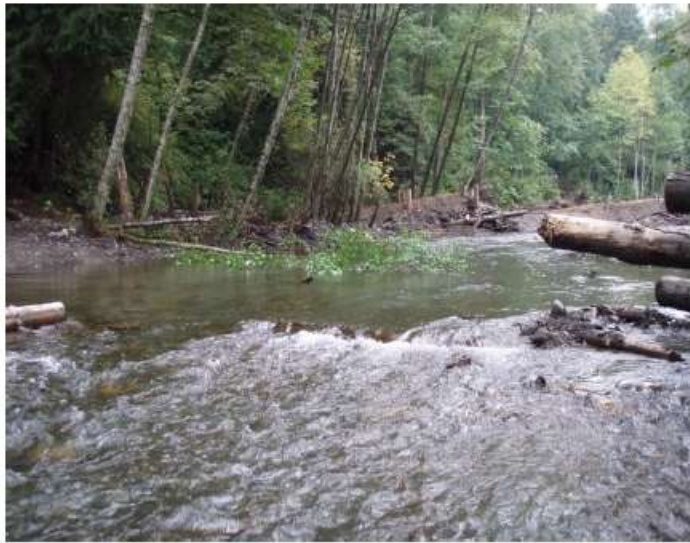
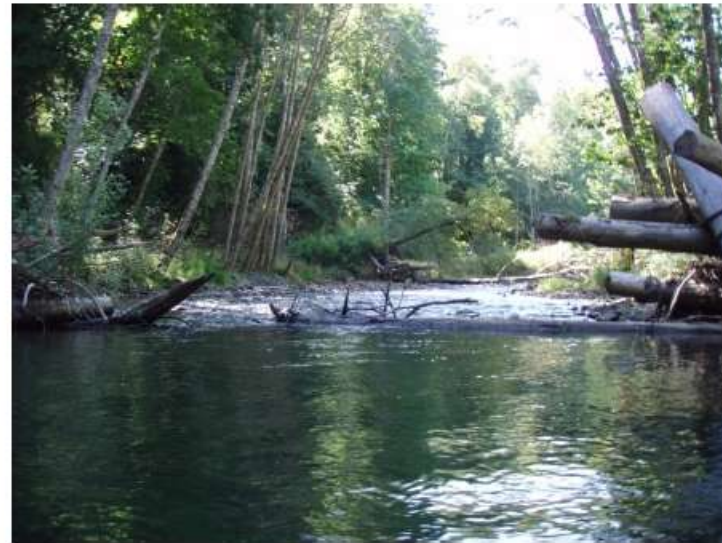
Figure 4.10. Photos from Cross-Section NC-3 looking downstream (above) and upstream (below) in 2010 (left) and 2012 (right).

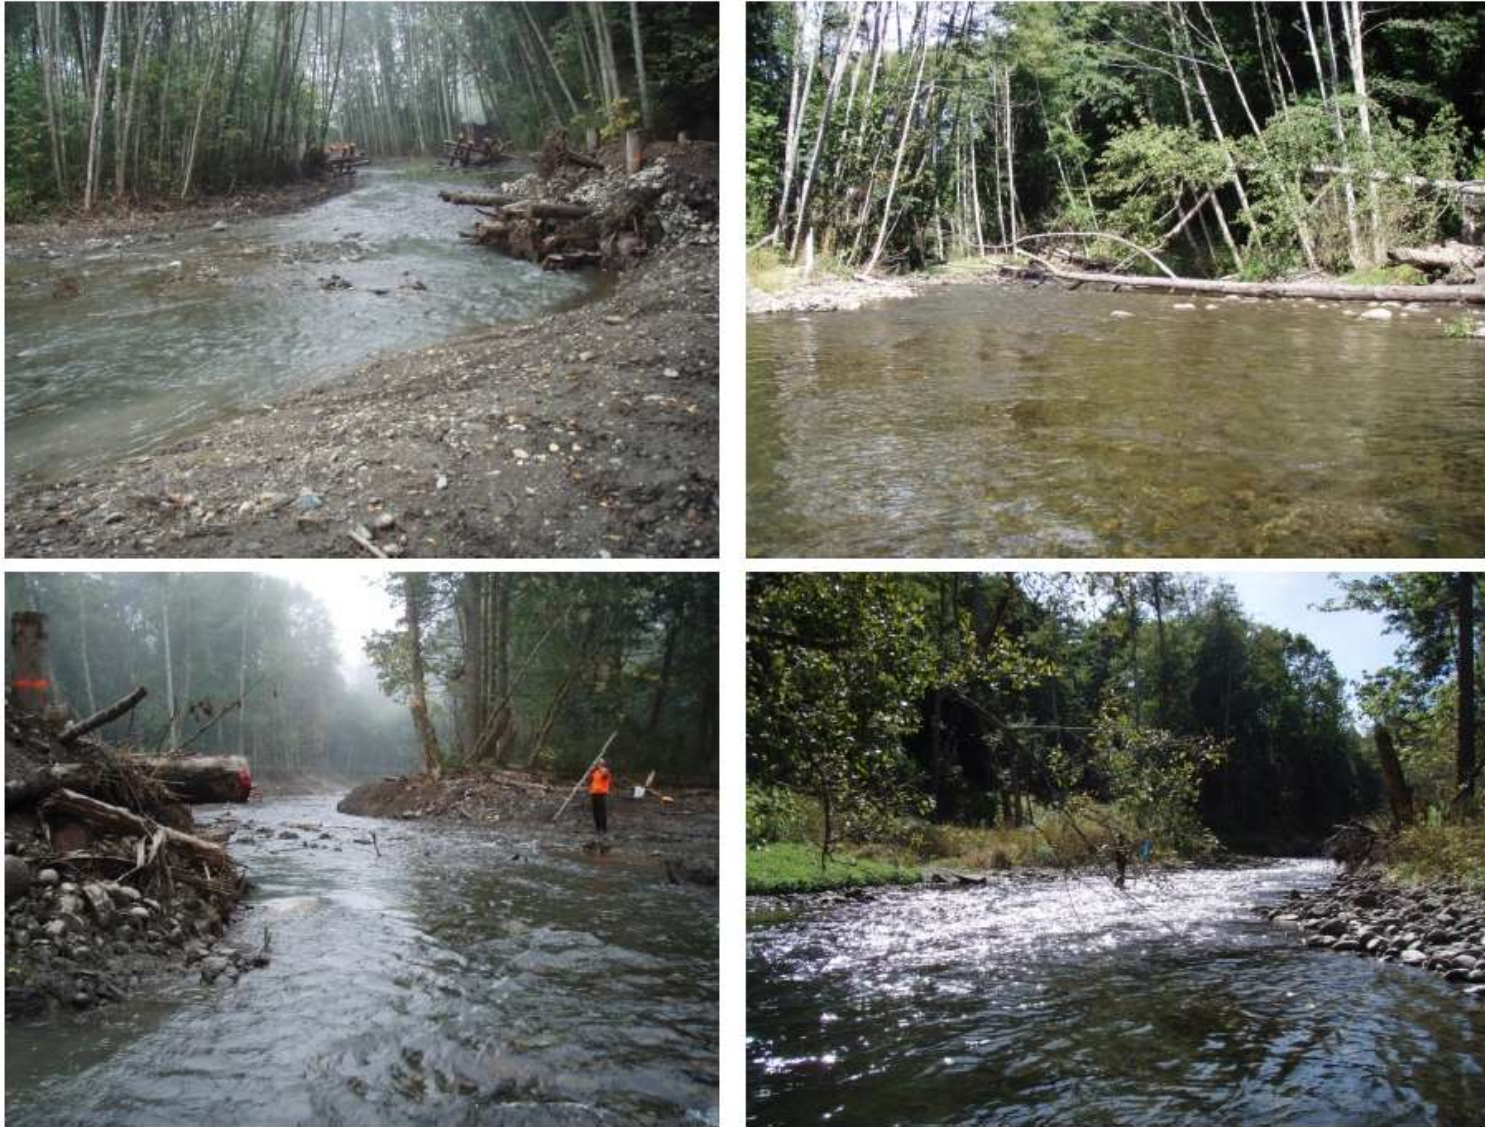
Figure 4.12. Photos from Cross-Section NC-4 looking downstream (above) and upstream (below) in 2010 (left) and 2012 (right).

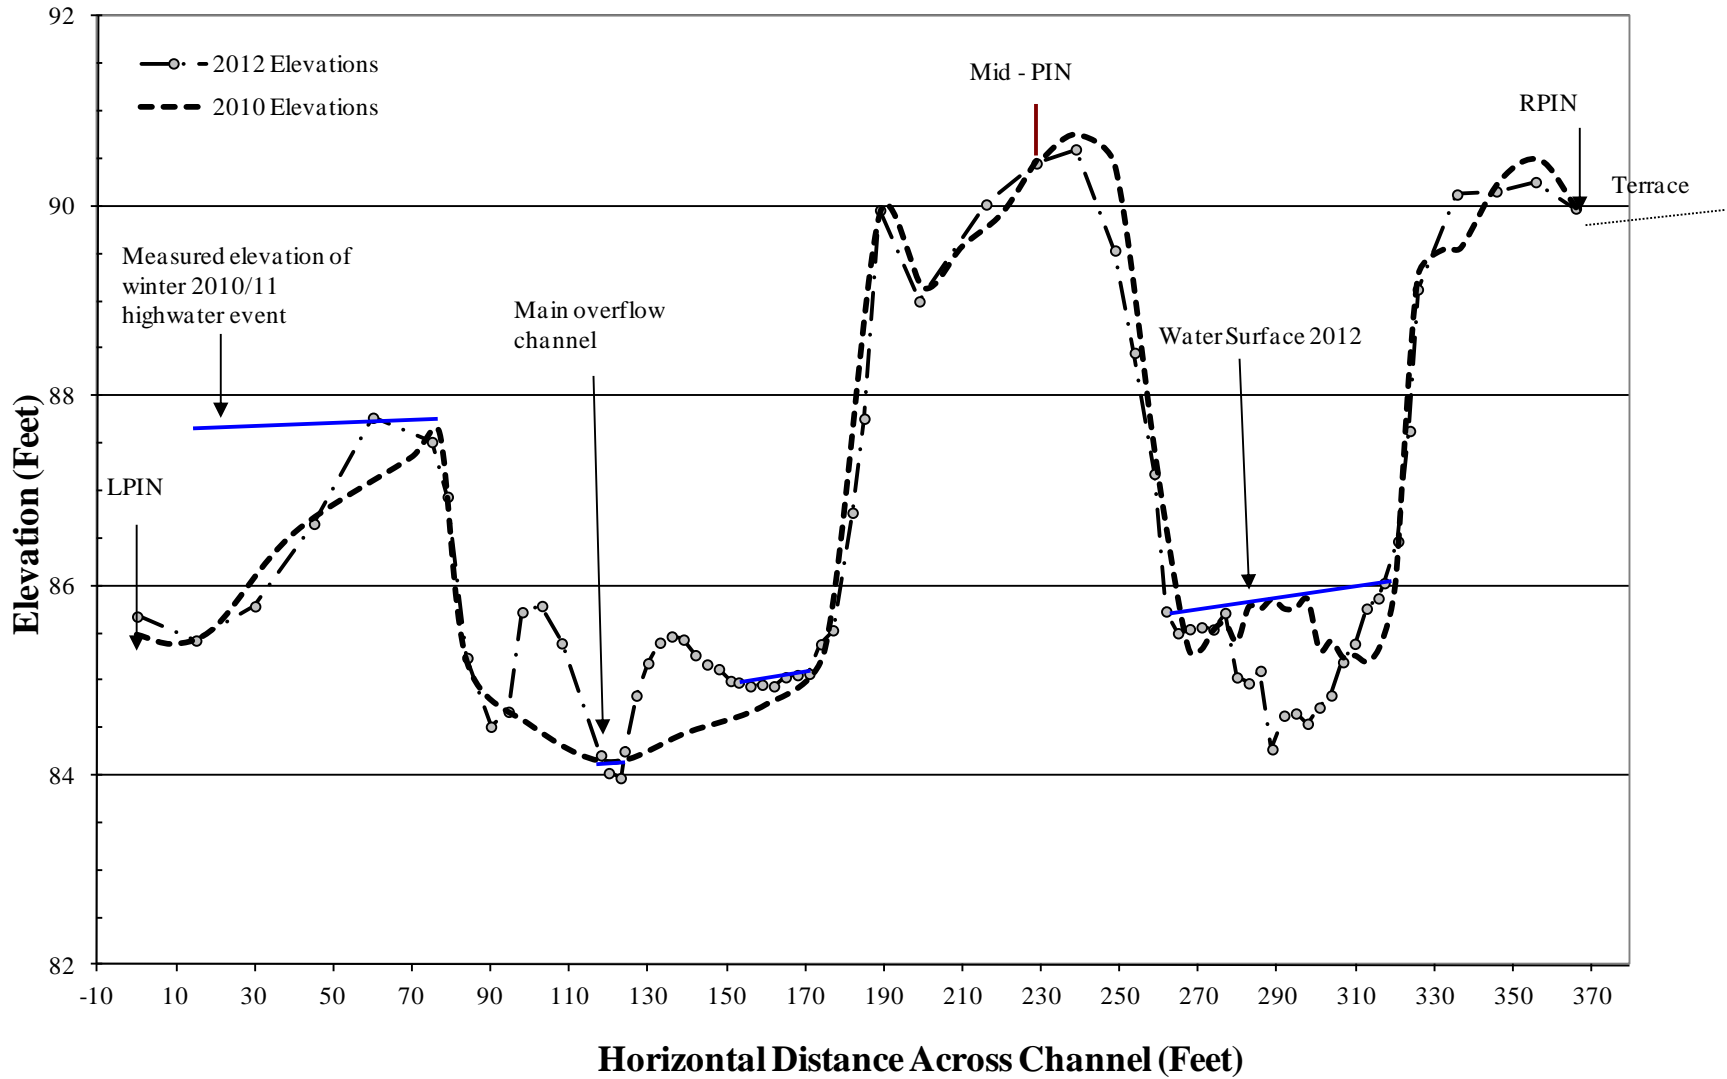
Figure 4.13. Morse Creek New Channel Cross-Section 5 in 2010 and 2012.

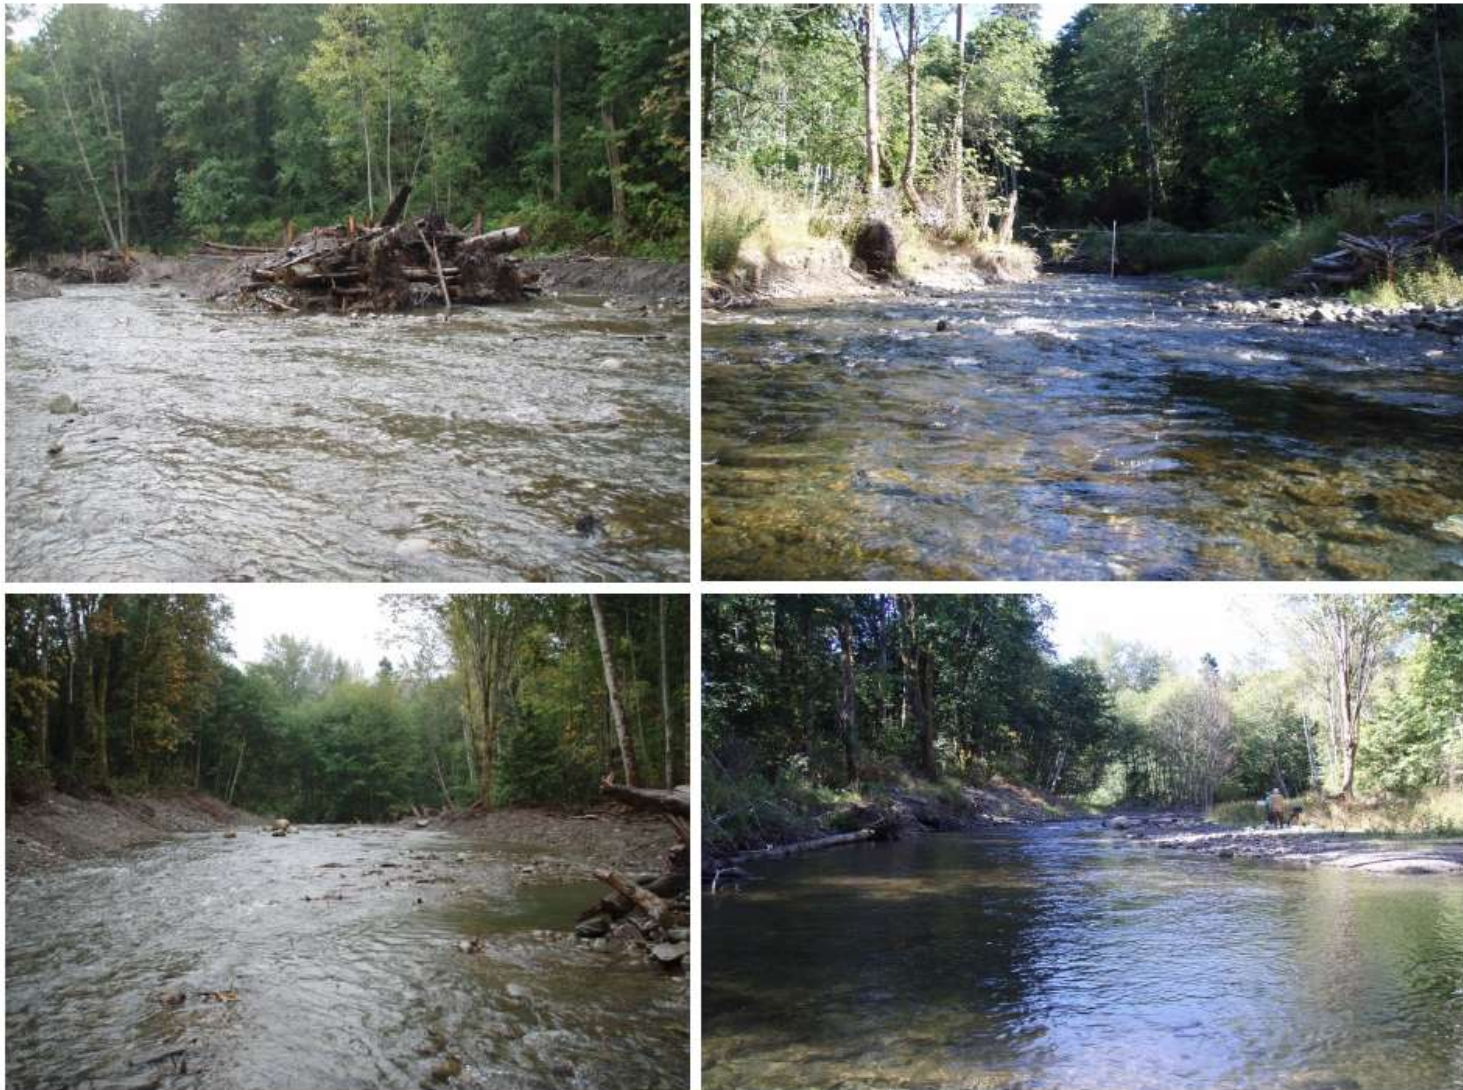
Figure 4.14. Photos from Cross-Section NC-5 looking downstream (above) and upstream (below) in 2010 (left) and 2012 (right).

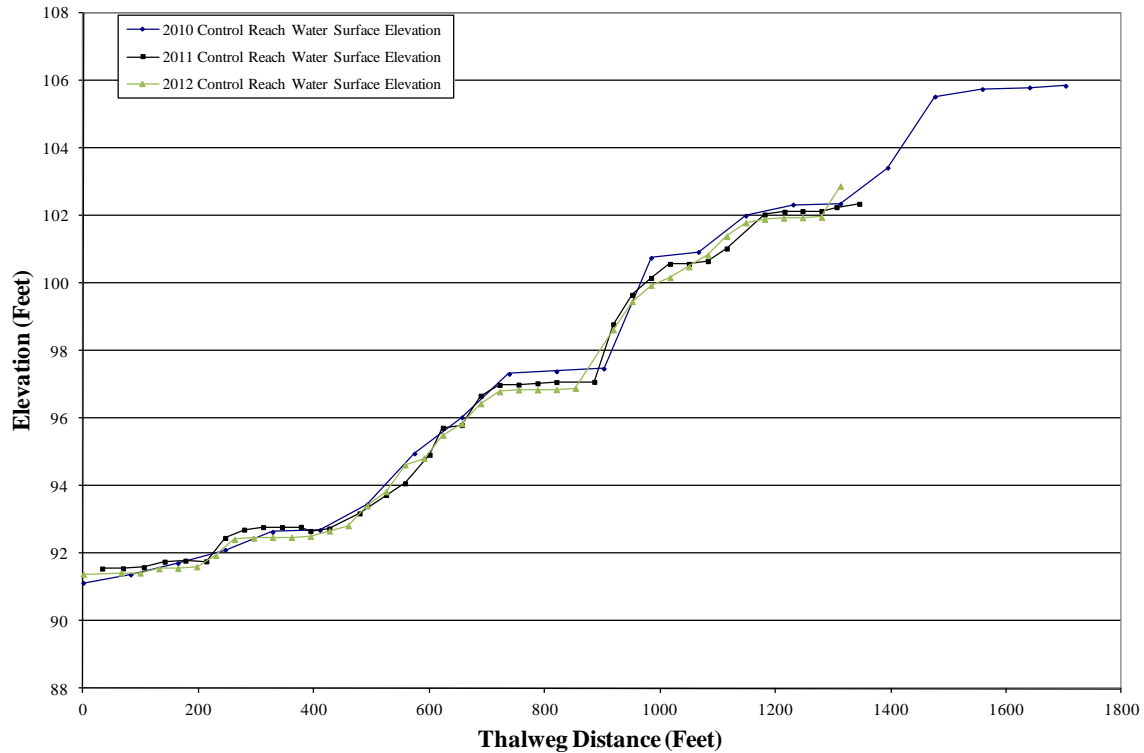
A thalweg substrate and water surface elevation profile was run upstream from the downstream end of the control reach (corresponds to the upstream end of impact reach 2). In 2010, water surface and substrate elevations were measured and recorded at 25 meter intervals; elevations were measured at a total of 21 stations. In 2011 and 2012, surface and substrate elevations were measured and recorded at 5 to 15 meter intervals; elevations were measured at a total of 39 stations. Reach level stream gradient was approximately 0.9% in 2010, 2011, and 2012.

Figure 4.23. Control reach water surface profile for data collected in 2010, 2011, and 2012.

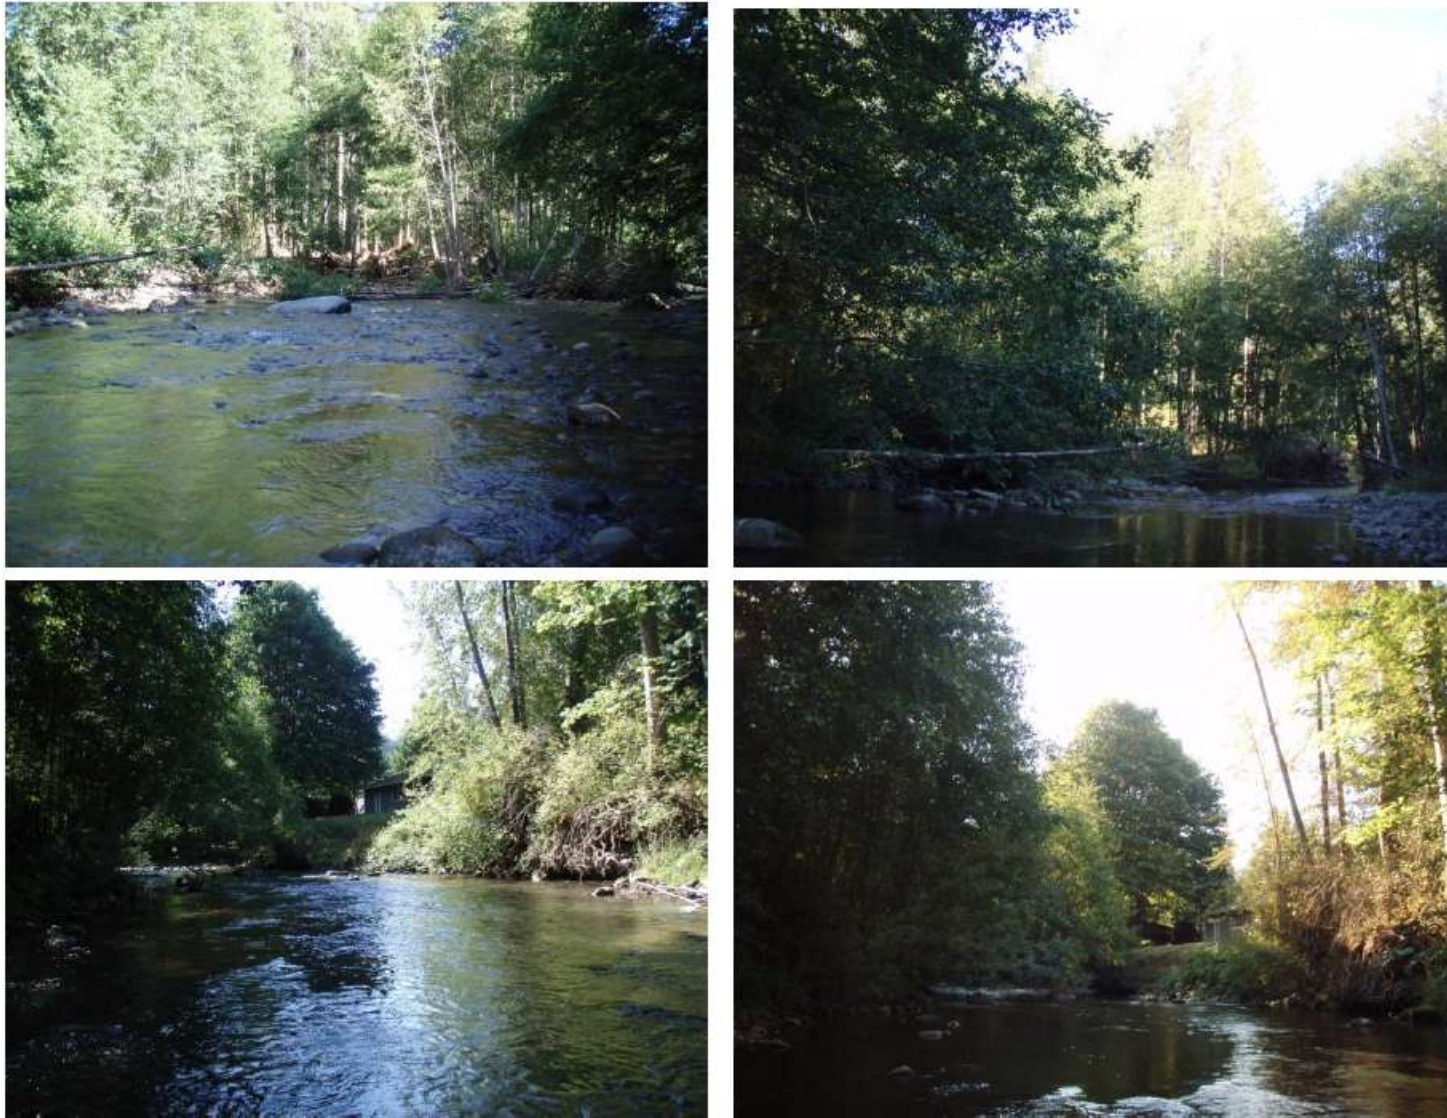
Figure 4.25. Photos from Cross-Section CR-1 looking downstream (above) and upstream (below) in 2010 (left) and 2012 (right).

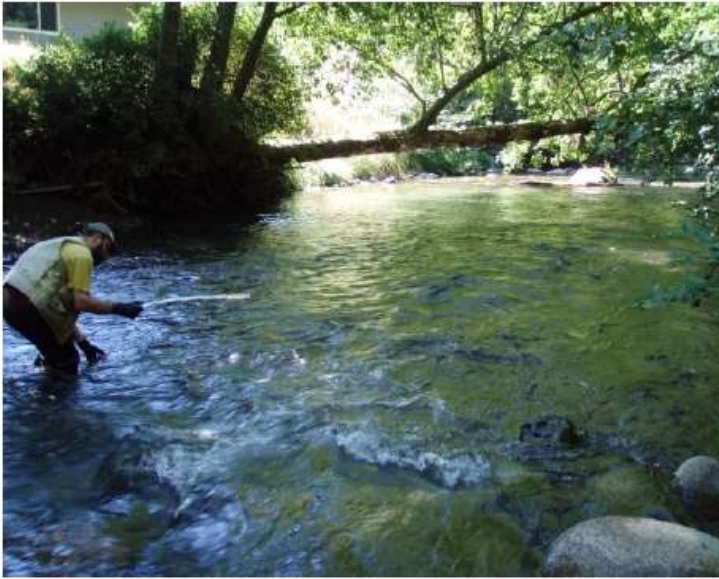
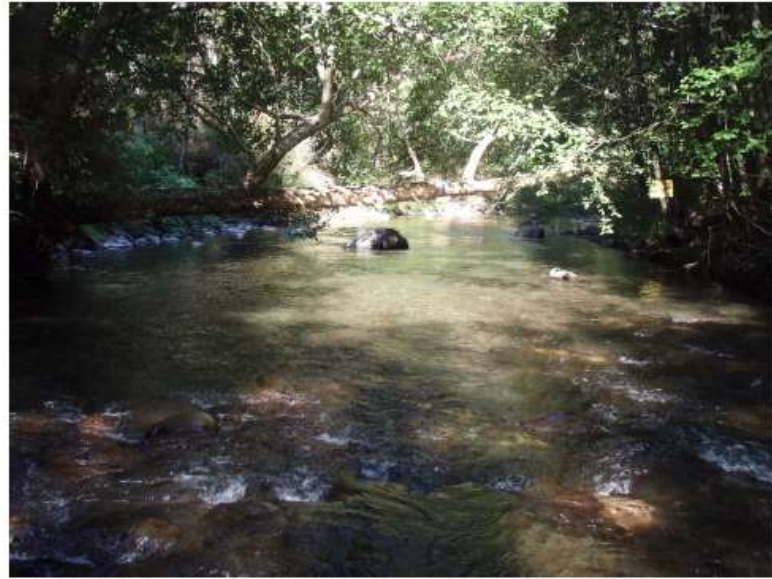
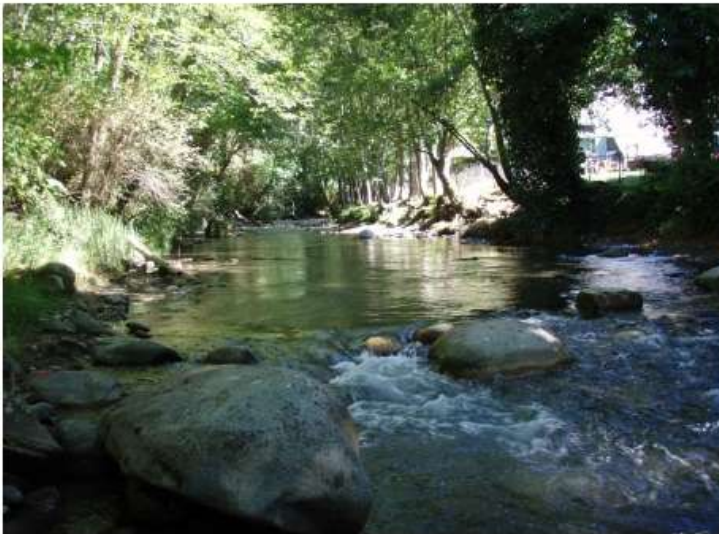
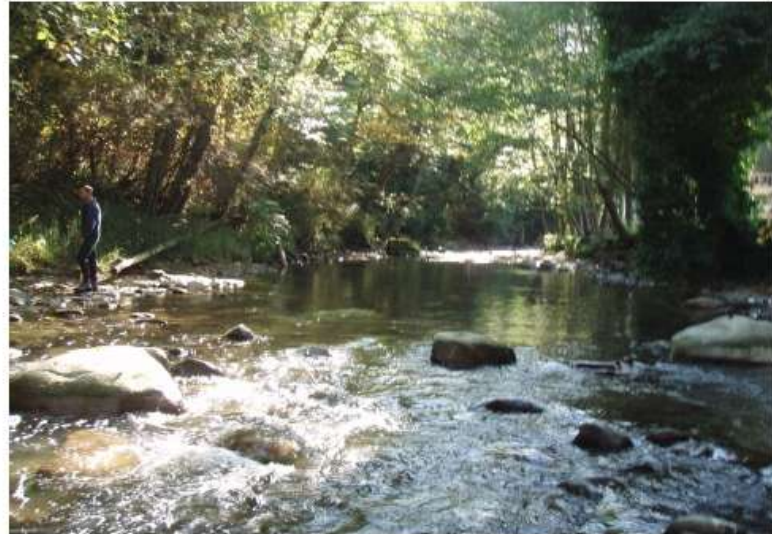
Figure 4.27. Photos from Cross-Section CR-2 looking downstream (above) and upstream (below) in 2010 (left) and 2012 (right).
