MORSE CREEK REMEANDER RESTORATION: MONITORING REPORT YEAR THREE

North Olympic Salmon Coalition and Mike Haggerty
Consulting

October 2012

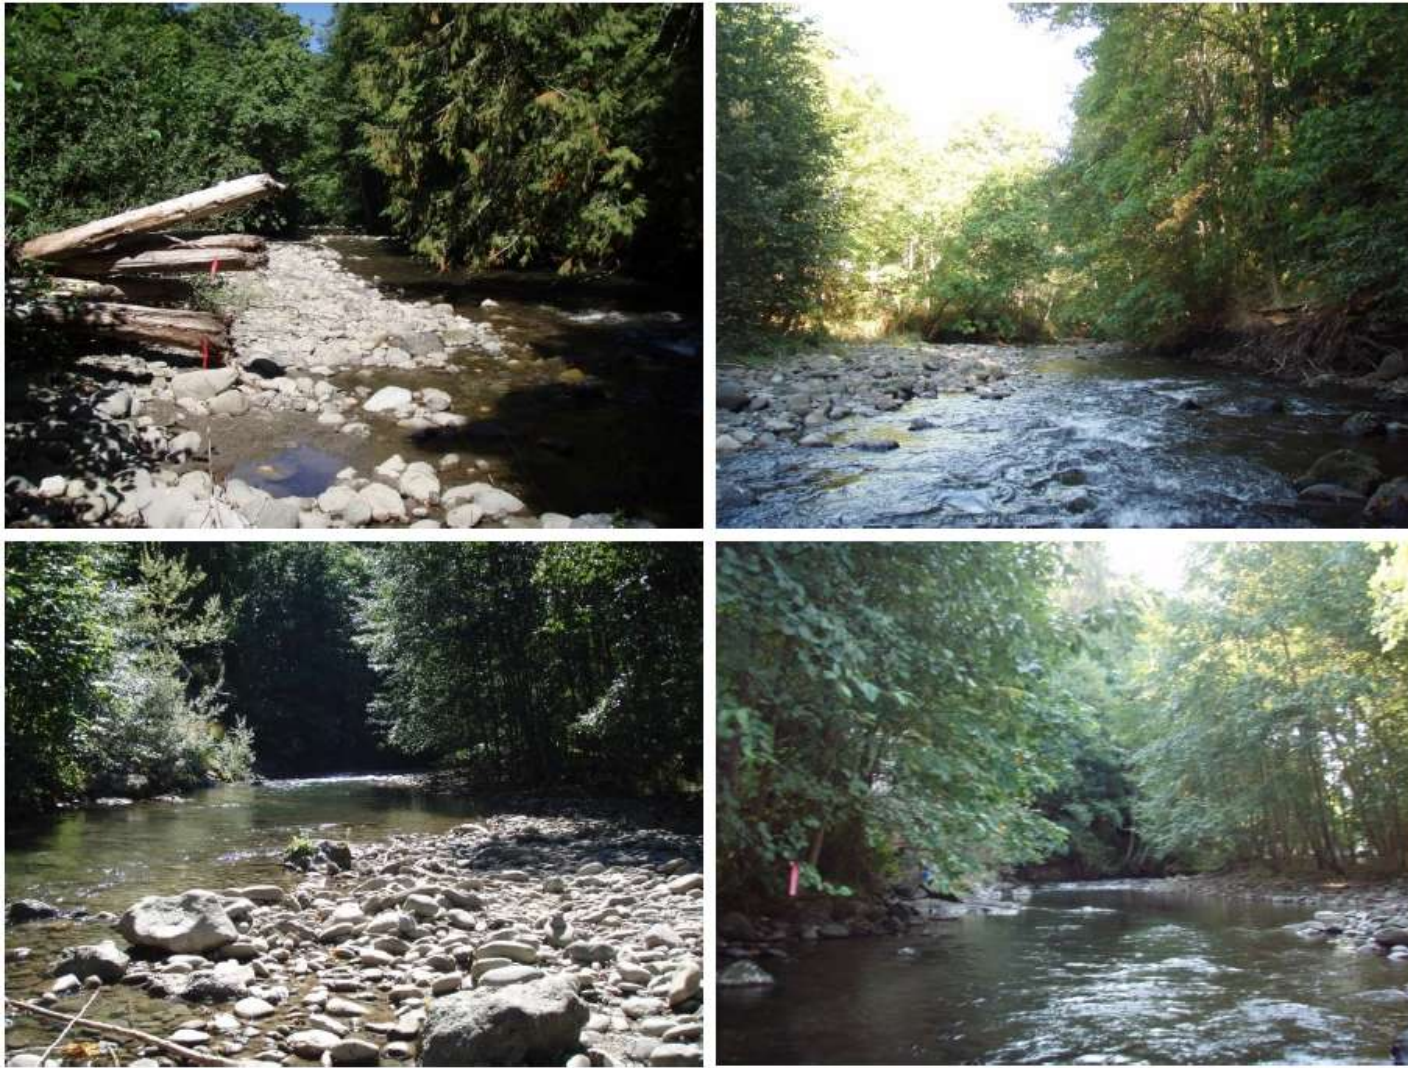
Figure 4.31. Photos from Cross-Section CR-4 looking downstream (above) and upstream (below) in 2010 (left) and 2011 (right).

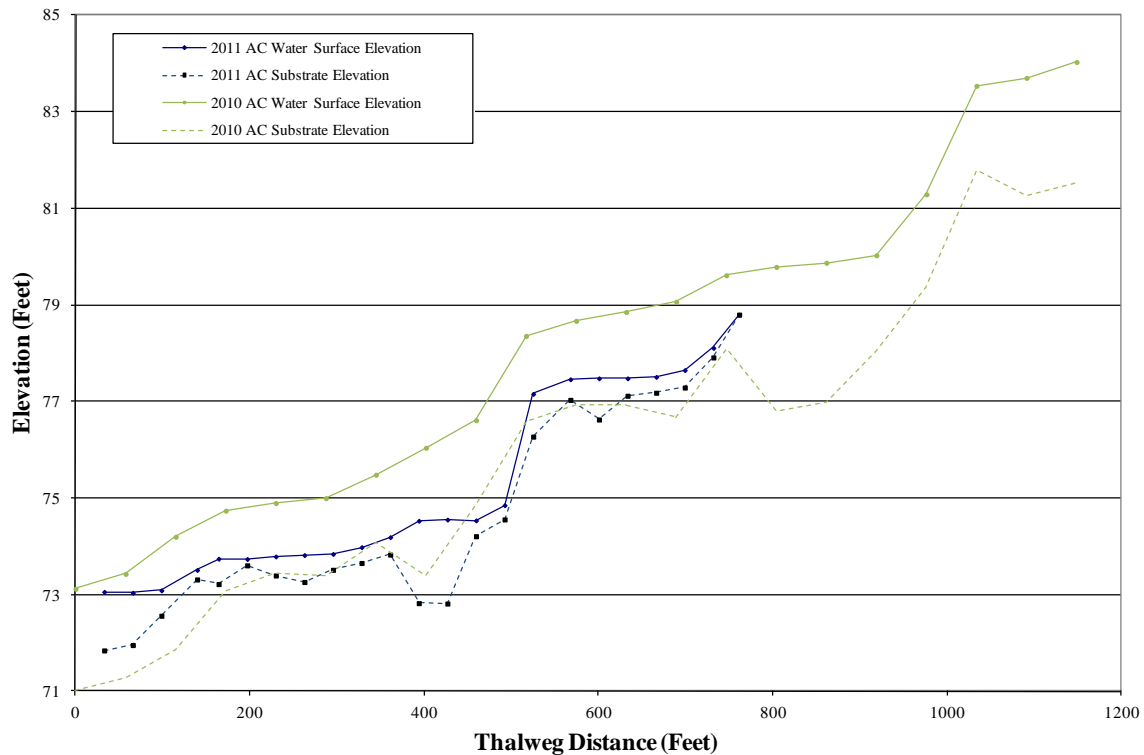
In 2012, a total length of 240 meters was surveyed. Stream gradient was measured at 10 to 15 meter intervals, 24 measurements were made. The water surface and substrate profile for this reach is depicted in Figure 4.37.

Figure 4.37. Abandoned channel reach thalweg water surface and substrate profile for data collected in 2010 and 2011.

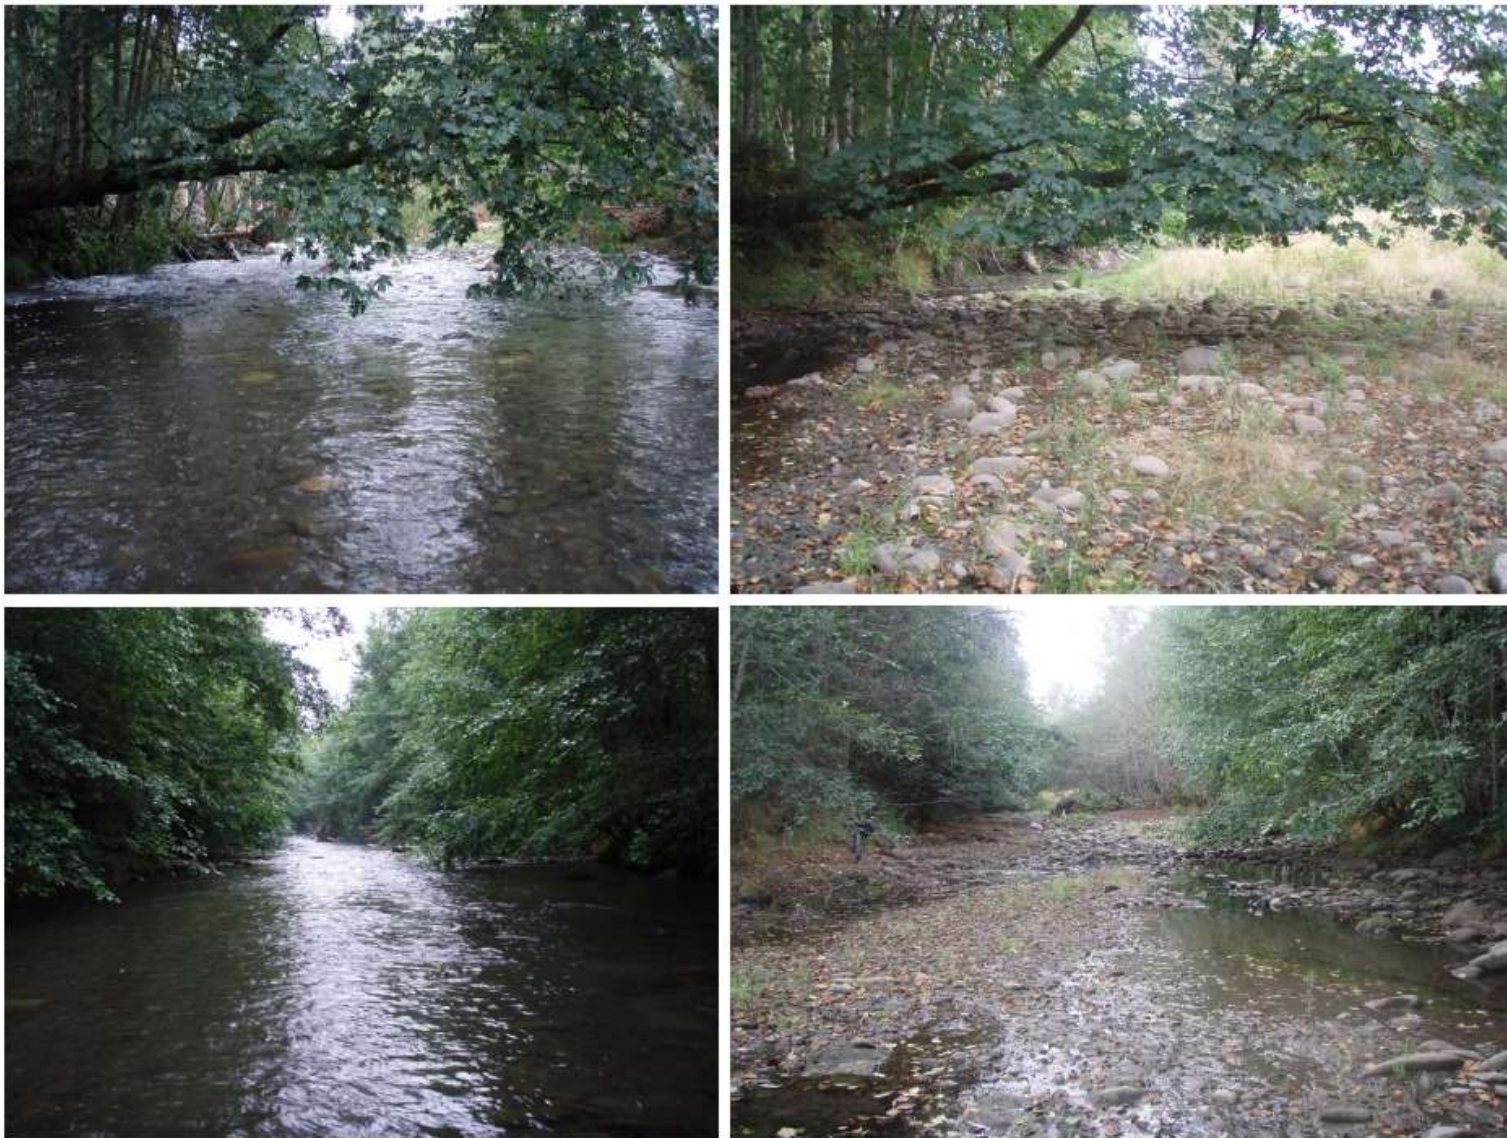
Figure 4.39. Photos from Cross-Section AC-1 looking downstream (above) and upstream (below) in 2010 (left) and 2012 (right).

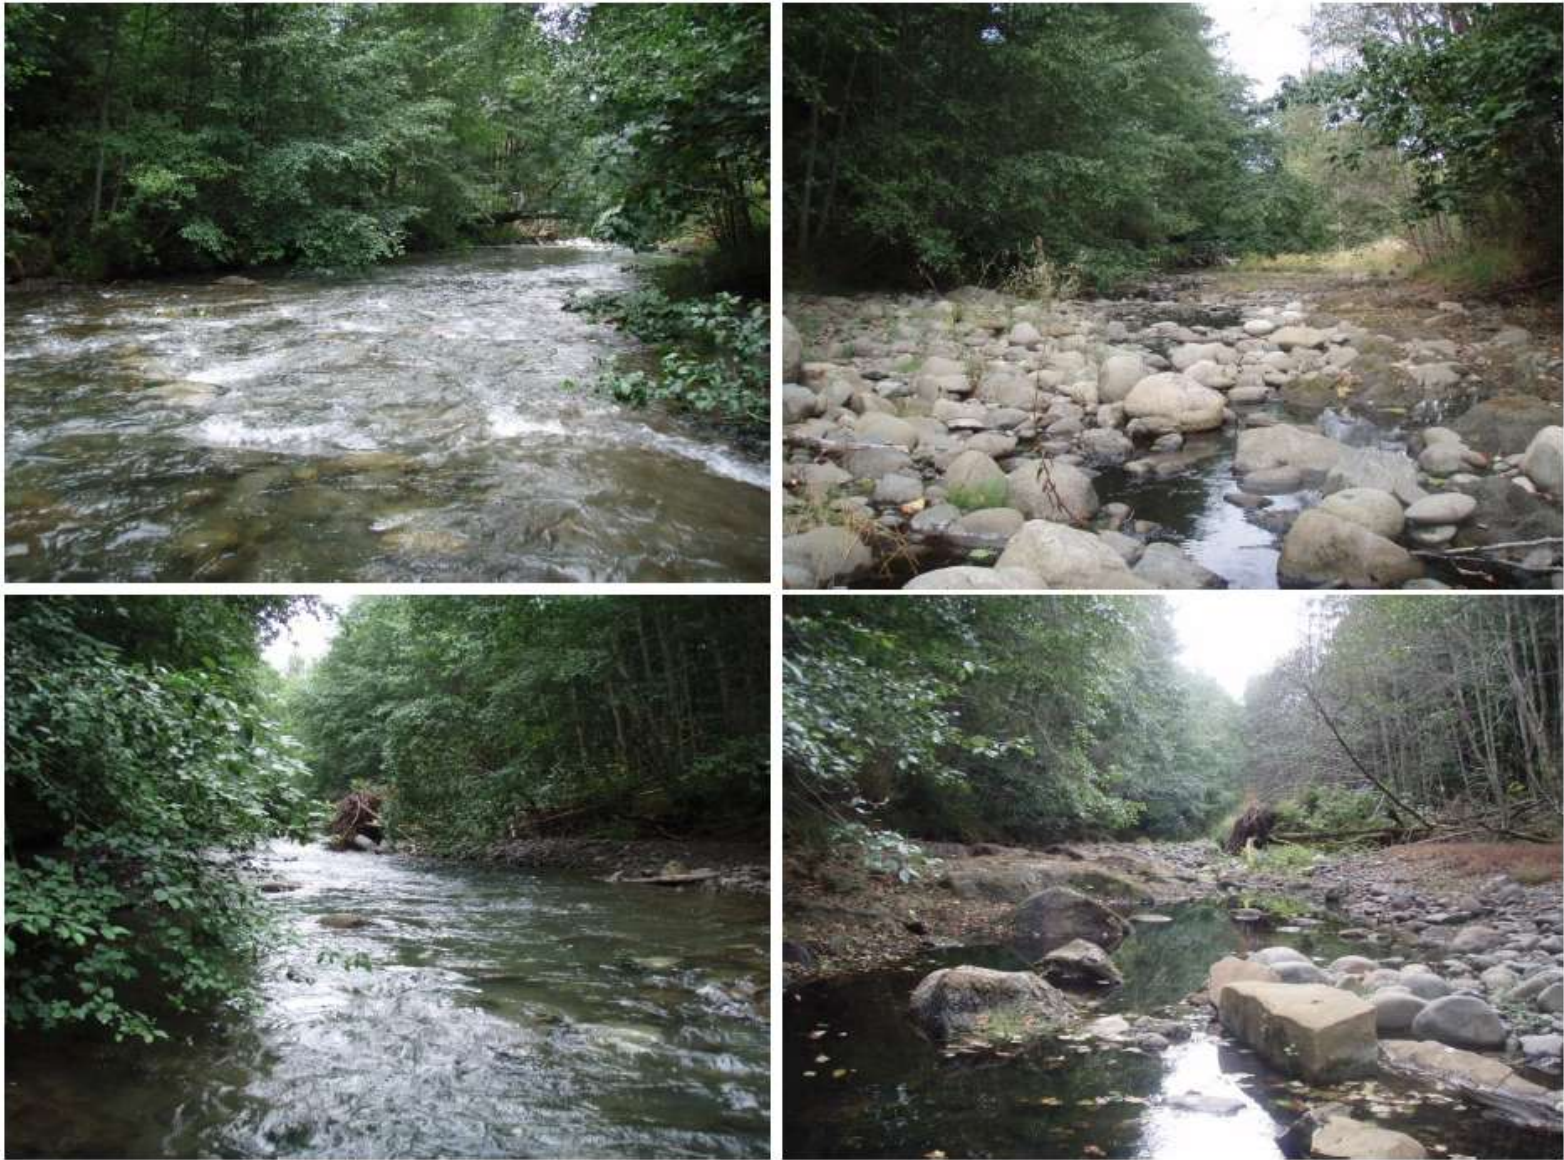
Figure 4.41. Photos from Cross-Section AC-2 looking downstream (above) and upstream (below) in 2010 (left) and 2012 (right).

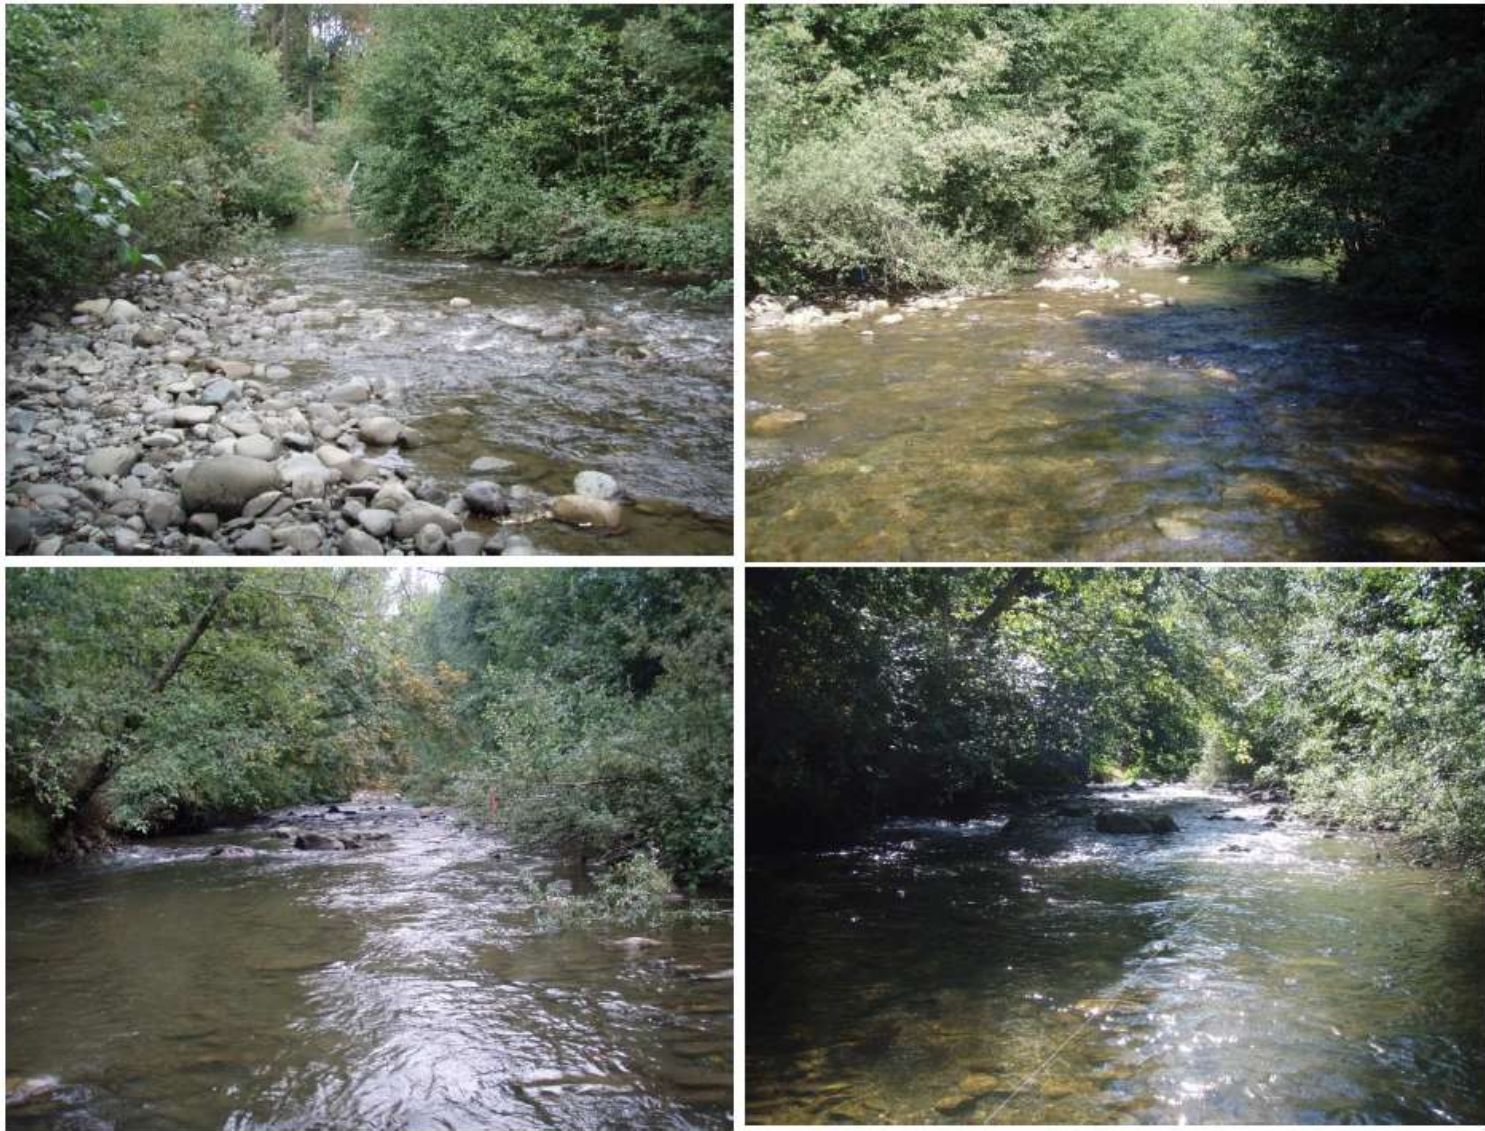
Figure 4.50. Photos from Cross-Section IR1-1 looking downstream (above) and upstream (below) in 2010 (left) and 2012 (right).

Two long-term monitoring cross-sections were established in impact reach 1 (see Figure 3.4). Cross-section IR1-XSEC 1 and IR1-XSEC 2 are located 14 meters and 146 meters upstream from the start of survey respectively. Annotated cross-section plots for IR1-XSEC 1 and 2 are included below in Figure 4.49 and Figure 4.51. Photos looking upstream and downstream at the cross-sections are included in Figure 4.50 and Figure 4.52.

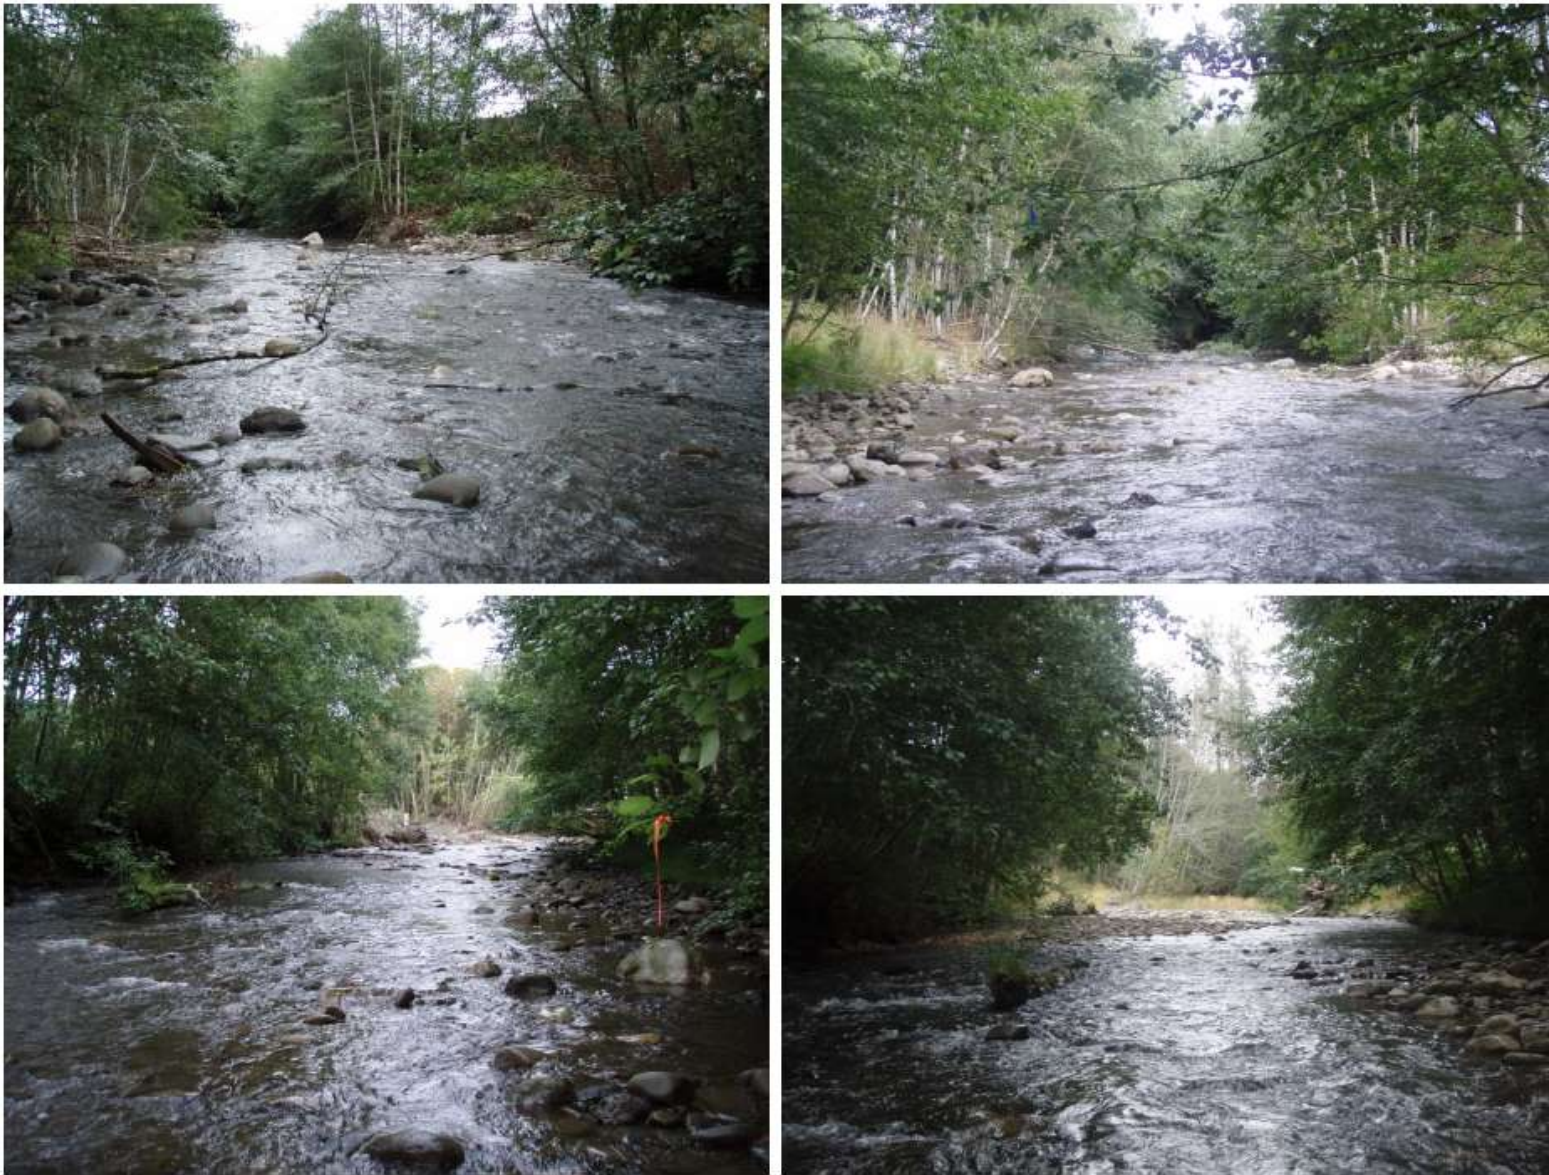
Figure 4.52. Photos from Cross-Section IR1-2 looking downstream (above) and upstream (below) in 2010 (left) and 2012 (right).

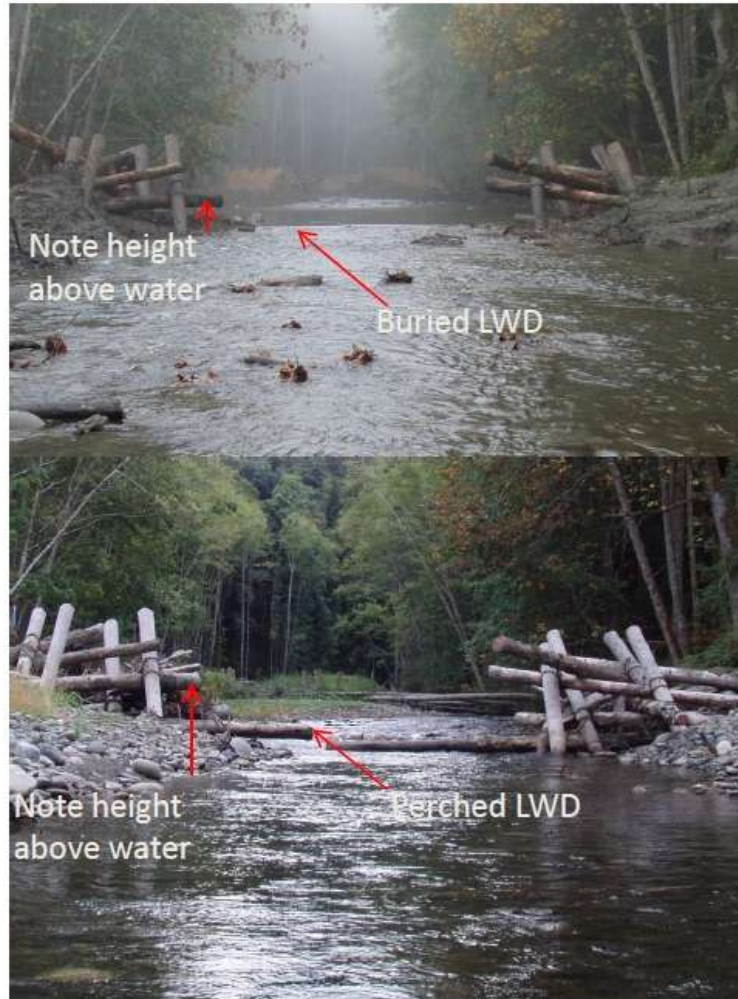
Figure 5.2. Photo depicting channel incision in the lower 50 meters of the new channel reach; top (2010) and bottom (2011).

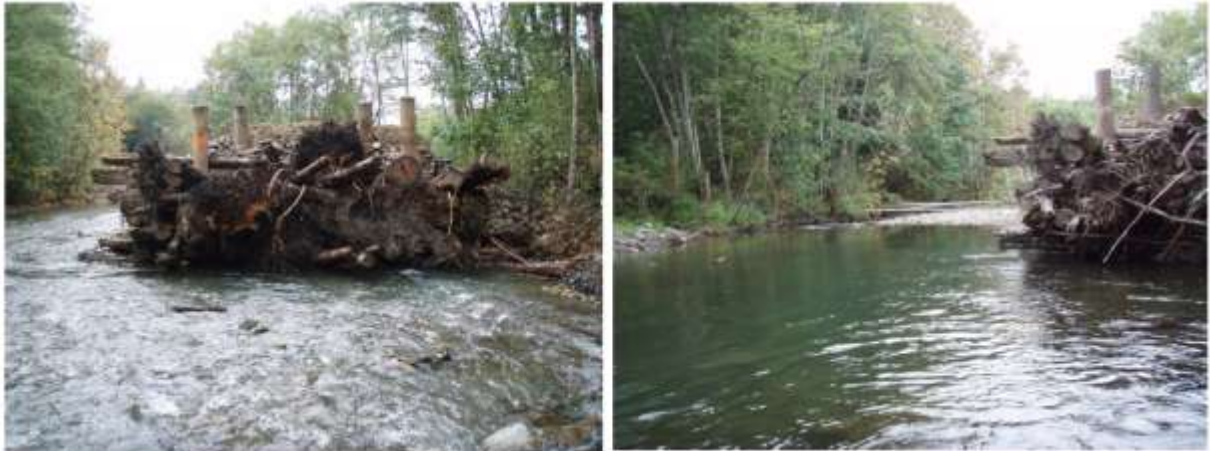
Figure 5.3. Photos depicting the development of large scour pool associated with LWD Jam #8 (Habitat Unit #6); left (2010) and right (2011).

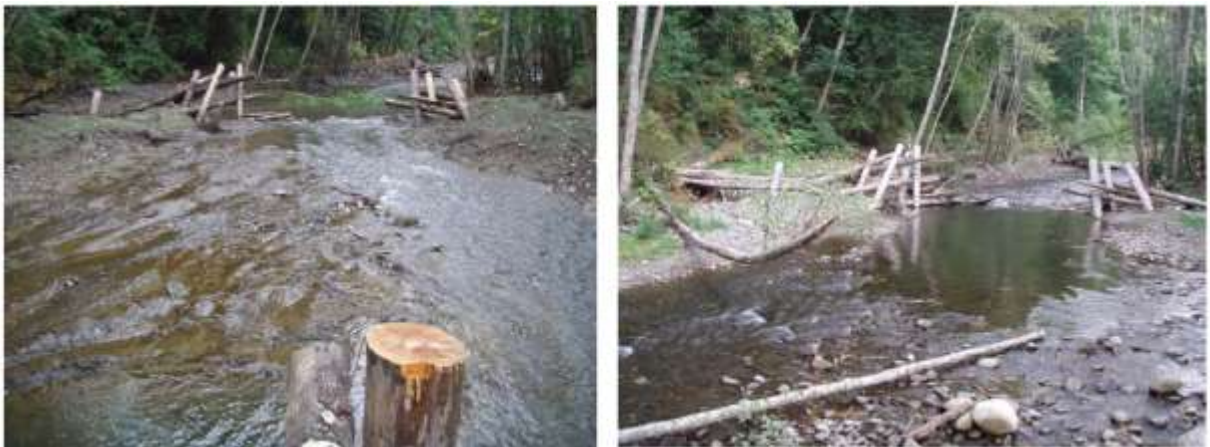
Figure 5.4. Photos depicting the development of large scour pool associated with LWD Jam #11; left (2010) and right (2011).

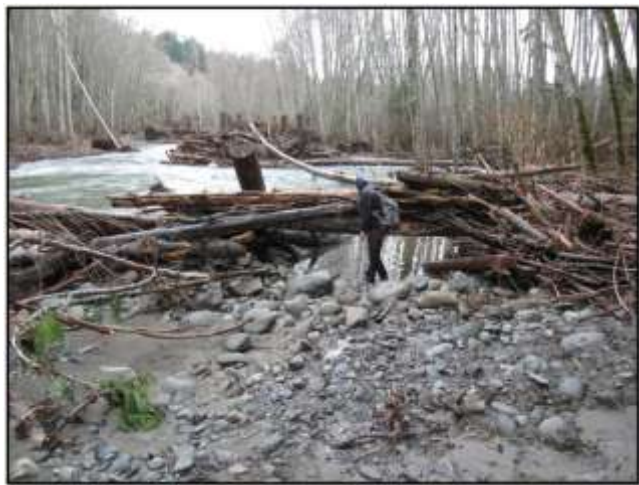
Figure 5.5 demonstrates the size, type, and volume of debris that has been captured by the engineered logjams during high water events. This logjam has scoured a deep pool that is utilized by juvenile salmonids for rearing and adults for holding. The two dominant species utilizing these habitats were coho

Figure 5.5. Photo looking at Logjam #11 and racked LWD trapped by jam.

salmon and steelhead trout. The pools and associated logjams are important rearing habitat for both of these species. The LWD creates areas of low water velocity, where fish seek refuge to improve in-stream survival. The number of pieces of LWD in the new channel reach is 60 to 70 times greater than what was documented in the abandoned channel reach.

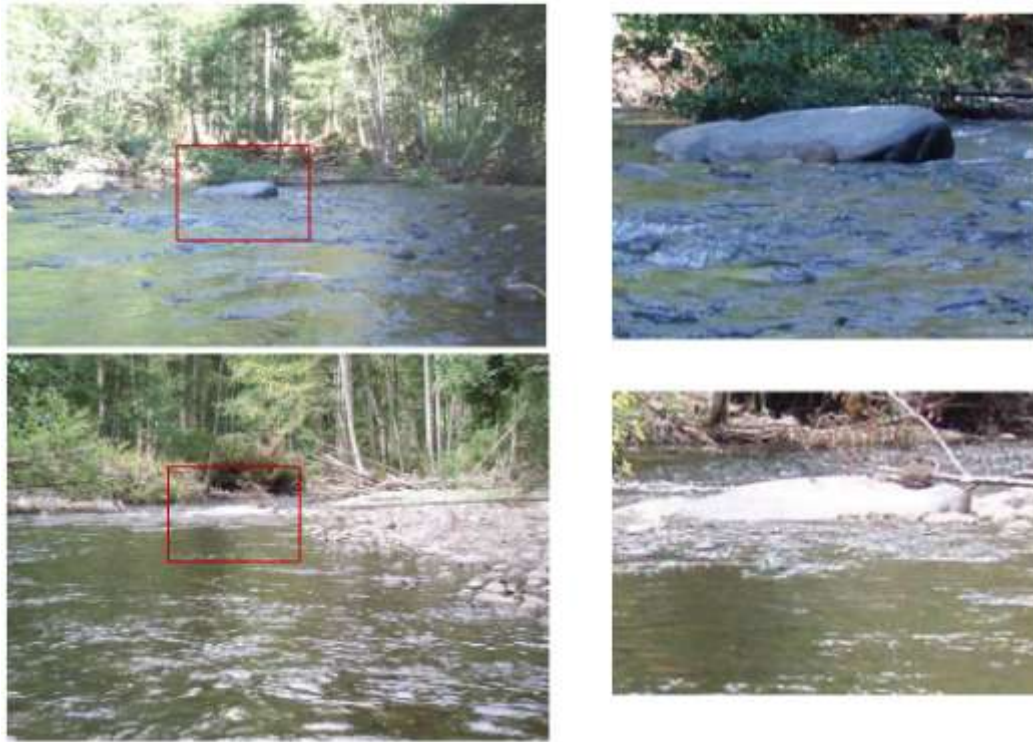
Figure 5.6. Photos looking downstream from CR-XSEC-1 at large boulder showing sediment aggradation between 2010 and 2011 surveys (Top photos taken in 2010; bottom photos taken in 2011).

Changes to streambed elevations and streambed particle size were observed within the lowest portions of impact reach 2 (Figure 4.56). Several feet of aggradation occurred within the right bank side channel. Aggradation was also evident at the upstream portion of impact reach 2. Figure 5.6 shows minor amounts (~0.5 to 1 ft) of aggradation adjacent to a large boulder.

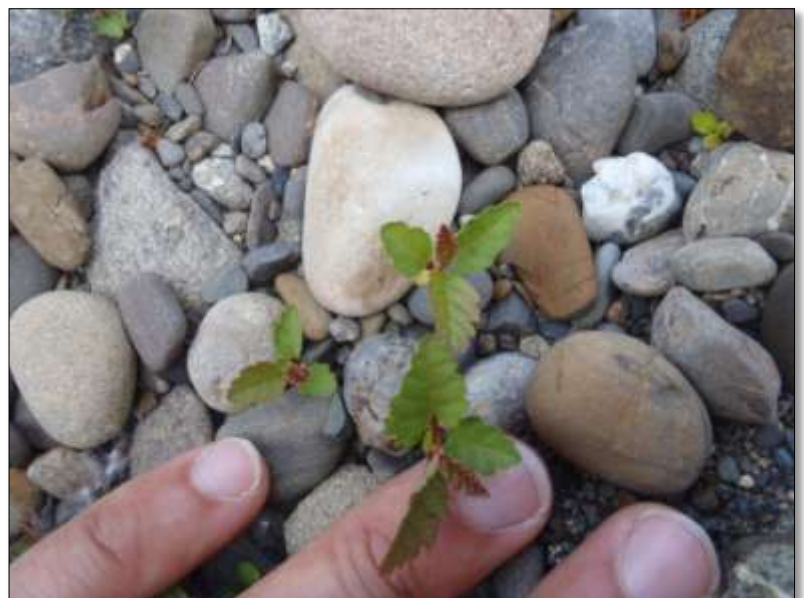
Figure 5.7. Example of red alder seedlings taking root in area disturbed by restoration project.

Although the canopy cover percentage is low, great care was taken during the restoration project to minimize tree removal and disturbance. Alder, maple and salmonberry seedlings have begun to recruit on surfaces that were disturbed by the restoration. It is anticipated that in the next 10-15 years, canopy cover will increase as deciduous trees fill in canopy gaps caused by the project. In addition, new riparian vegetation will grow over the years and eventually provide additional shade. In order to speed succession, conifers (Douglas fir, western red cedar, western hemlock and sitka spruce) were planted amongst the alder and big-leaf maple. Since restoration, the number of trees planted within the riparian area of Morse Creek totals more than 3,000.
