2002 Houck Creek Erosion Control Project

Project Overview

Location: Houck Prop.- Houck Creek
Erosion Control Measures: 1000 cubic yards of rock and willow staking along banks

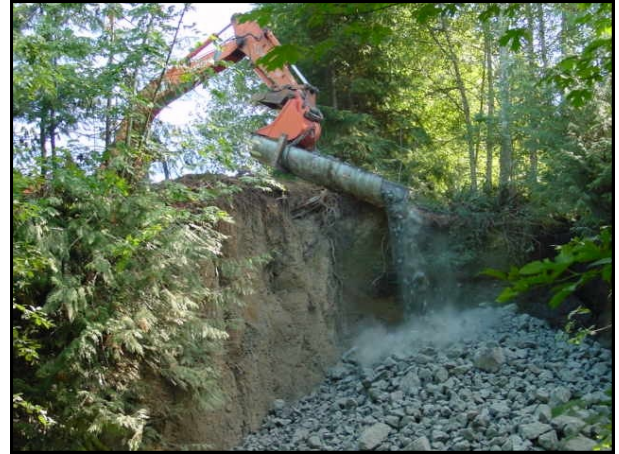
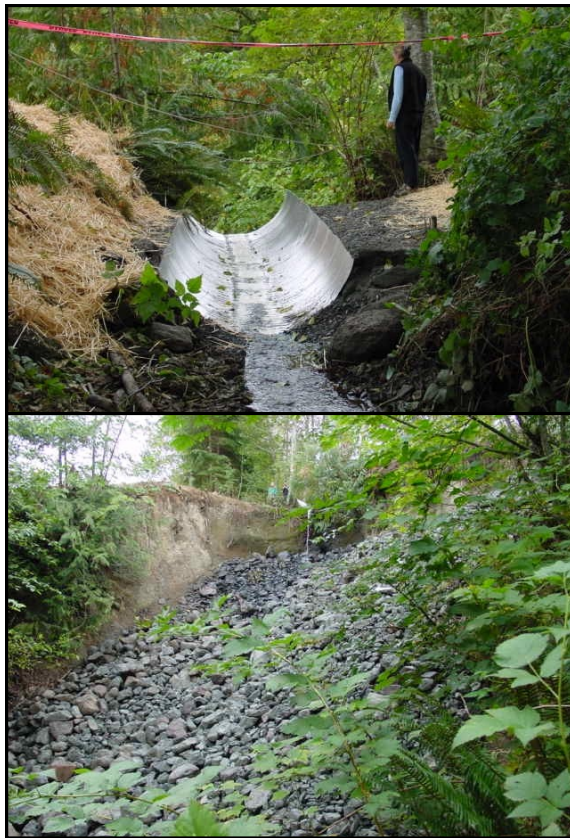
Houck Creek, a tributary of Salmon Creek, had a major erosional scarp below its pond that was resulting in an increased sediment load entering Salmon Creek. This sediment overload decreases the quality of salmon habitat downstream from the site. Both coho and ESA-listed Hood Canal summer chum spawn in the downstream waters.

The project consisted of filling the drainage ravine with rock and planting willow stakes. Increasing vegetation on the remaining scarp slope will reduce erosion, stabilize the slope and help filter the sediment before it reaches summer chum spawning gravels downstream. Jefferson County Conservation District's measurement of turbidity before and after has validated the project's immediate success.
